Evaluation of the report of the Tokyo Electric Power Company regarding the leakage from the double strainer differential manometer for the water transfer pipes of the desalination system at Fukushima Daiichi Nuclear Power Station

15 April 2015
Nuclear Regulation Authority, Japan

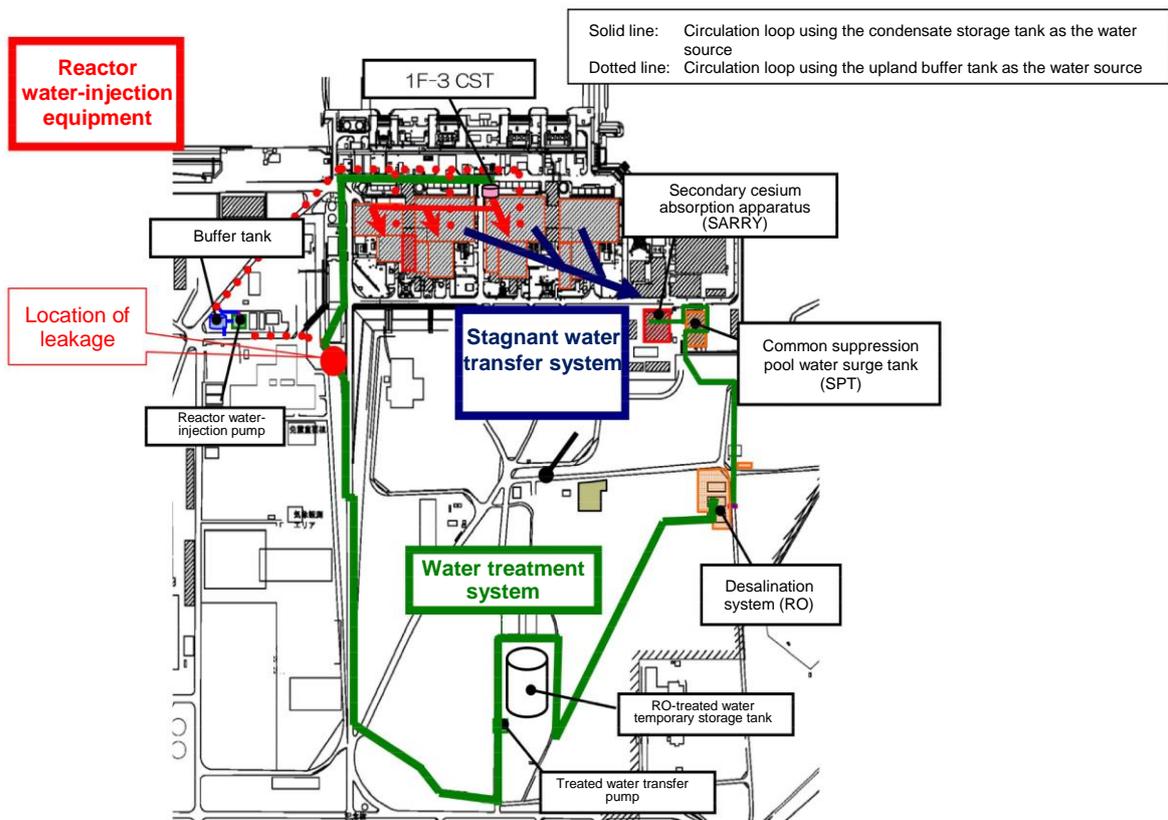
Figure 2 Approximate position of the leakage (extracted from the Secretariat of the NRA's document for a meeting with TEPCO)

RO-treated water that had leaked from the differential manometer spilled out of the drain water receiver of the mount installed in the lower part of the double strainer and permeated the soil. Tokyo Electric Power Company (hereinafter, referred to as “TEPCO”) confirmed that there was no indication that the leaked water had flowed outside the wall of sandbags placed around the mount, and there was no trace of water flow in the side ditch near the location of the leakage.

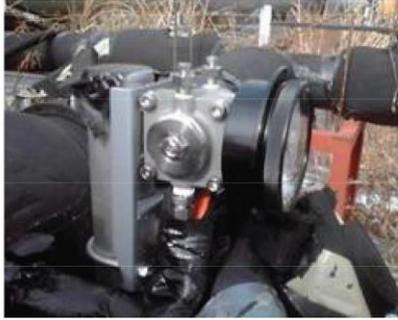
External appearance of the affected differential manometer
 Note: No traces of damage (scratches, deterioration, etc.) on its exterior

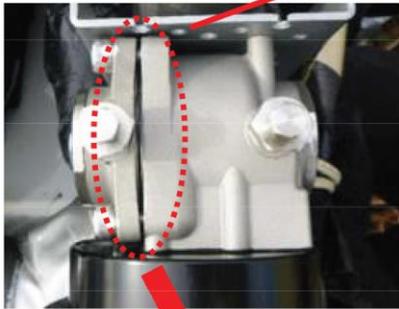
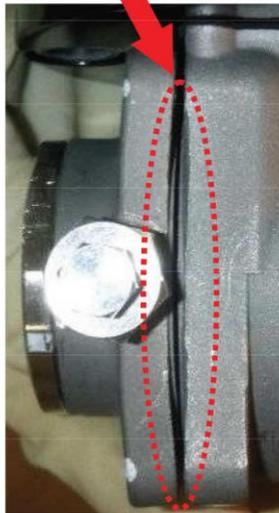
Before the event occurred, low-temperature conditions persisted inside the lagging material of the differential manometer due to the low outside air temperature (around -6°C) from around 22:00 on 5 February 2014 to around 4:00 on 6 February 2014. Because of this, the RO-treated water inside the differential manometer exposed to outdoor air via the body froze and increased in volume, which led to deformation of the bonnet flange and loosening of the bonnet flange bolts. It is assumed that the bonnet flange thus lost its sealing function and leakage occurred from the seal portion when the frozen RO-treated water melted. Moreover, due to the fact that other instruments having operating temperature ranges similar to that of the relevant instrument (operating temperature range: -5 to 40°C , however, the fluid should not be allowed to freeze) had been used successfully outdoors at Fukushima Daiichi Nuclear Power Station, it was considered sufficient to attach lagging material as a freeze-proofing measure when choosing such an instrument.

Condition of the bonnet flange (top)
 Note: The flange is slightly swollen and the O-ring is projecting out of the flange.

The entire double strainer, including the differential manometer, was covered with an acrylic cover, and two fan heater units were placed under the cover. As a countermeasure against leakage outside the system, a concrete dike was installed around the double strainer. For instruments installed outdoors or in locations

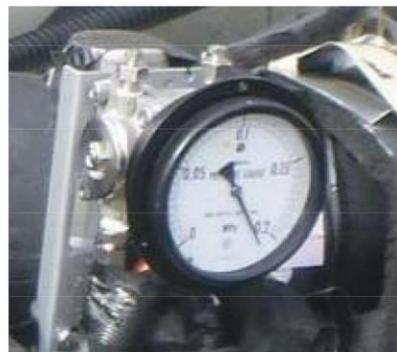
Reading of the affected differential manometer when leakage occurred
 Note: The indicator is off the scale.
