17 September 2015  
Nuclear Regulation Authority, Japan

## Leakages of water from the dikes in tank areas storing contaminated water at Fukushima Daiichi NPS

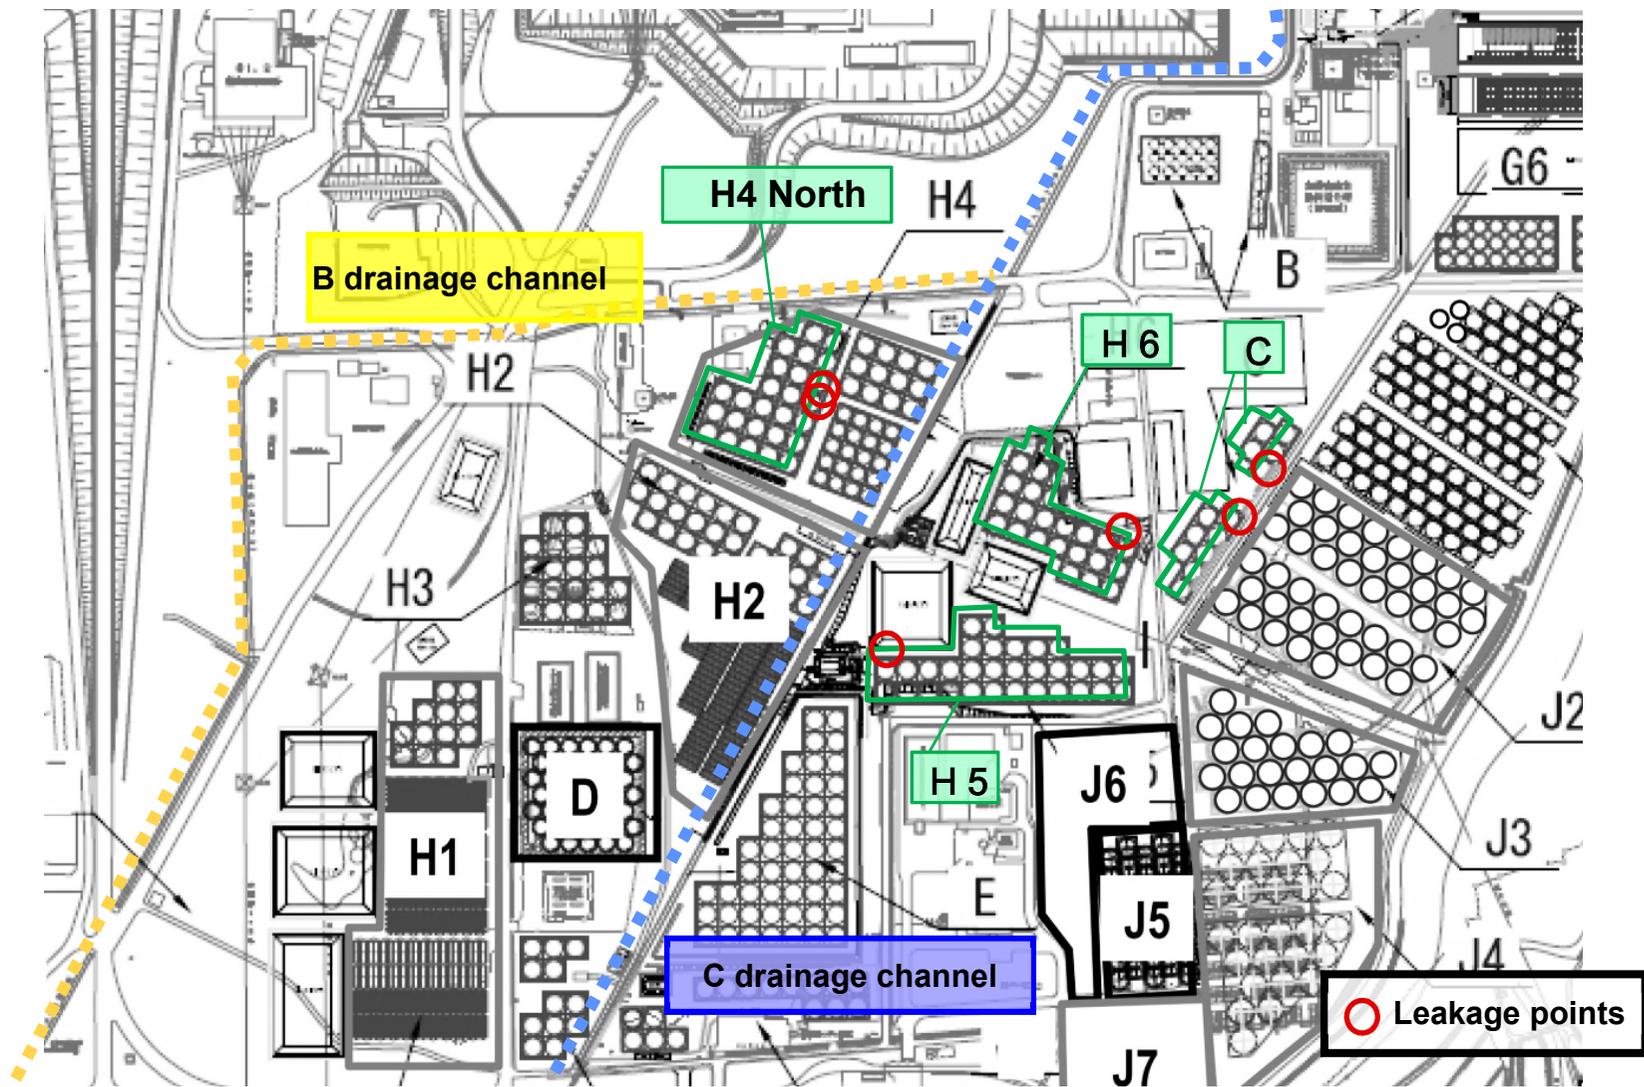
### Tank areas & Leakage points

- The report delineates the incident in which water accumulated in the dikes due to rainfall was found to be leaking in 4 areas (H5, C, H6, and H4 North as shown in Attachment\*) between 9 and 14 September 2015.
- The dikes are installed in order to prevent contaminated water from spreading in case a leakage from the tanks would occur. The water levels of tanks in each of the 4 areas show no change, suggesting there are no leakage from the tanks.
- There was no effect on the ocean throughout this incident.
  - At tank areas H5 and C, the concentration of radionuclides in the leaked water was lower than the water flowing through the drainage channels B and C during rainfall.
  - At tank areas H6 and H4 North, water discharge valves had been closed, so the leaked water did not flow into the drainage channels.

1. To continue monitoring including drainage channels monitoring in succession and sampling of groundwater around tank areas;
2. To screen, inspect, and treat the dikes to prevent further leakage;
3. To appropriately manage the water in the dikes taking into account this incident.
