# **Evaluation of the report of Tokyo Electric Power Company regarding the inflow of water that accumulated in the process main building into the incineration building at the Fukushima Daiichi Nuclear Power Station**

15 April 2015  
Nuclear Regulation Authority, Japan

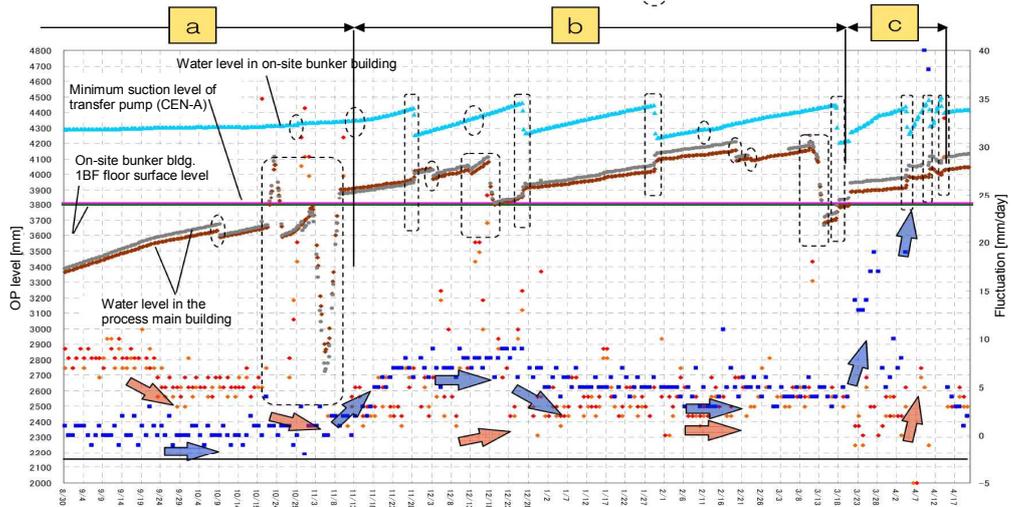
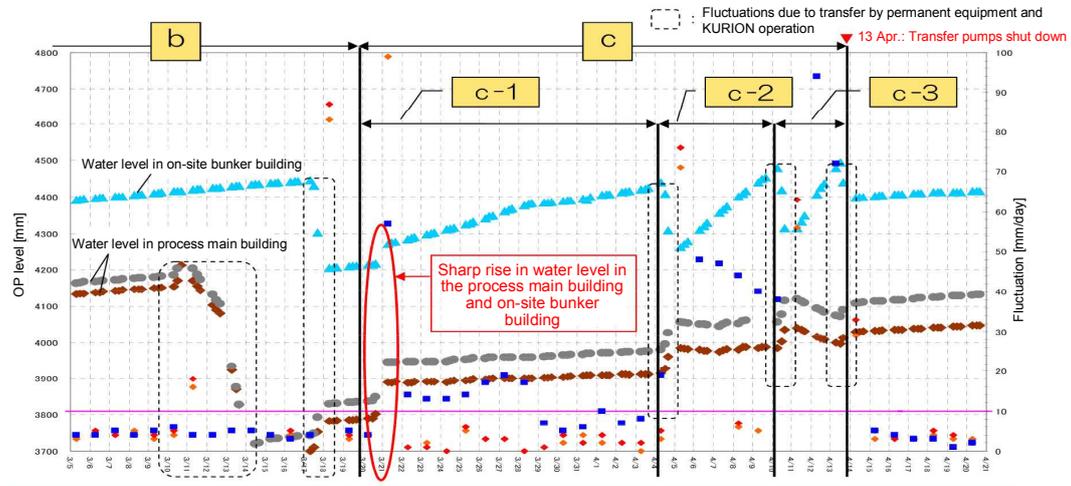
Figure 1-4 Estimating when the transfer pumps were activated

Around 12:00 p.m. on 11 April 2014, periodic water level monitoring found that the water level in the on-site bunker building was rising while that in the process main building was declining, despite the ongoing transfer of water accumulated in the on-site bunker building to the process main building (refer to Figures 1-1 to 1-4).

- Until 19 March 2014, the water level had barely or modestly risen, indicating fluctuations equal to or smaller than those observed from 14 April 2014 onward, when the transfer pumps were shut down.
- At noon on 20 March 2014, the water levels in the process main building and on-site bunker building began to rise sharply.

- b** Period of steady water level rise in the on-site bunker building (approx. 5 mm/day) (mid-November 2013 to late March 2014)
- c** Period of further water level rise in the on-site bunker building (10 mm/day or more) (late March to early April 2014)
- c-1** Period of sharp water level rise in the process main building and on-site bunker building (noon, 20 March to 3 April 2014)
- c-2** Period of water transfer from the on-site bunker building to the process main building (4 to 9 April 2014)
- c-3** Period of water transfer from the on-site bunker building to the process main building (10 to 13 April 2014)

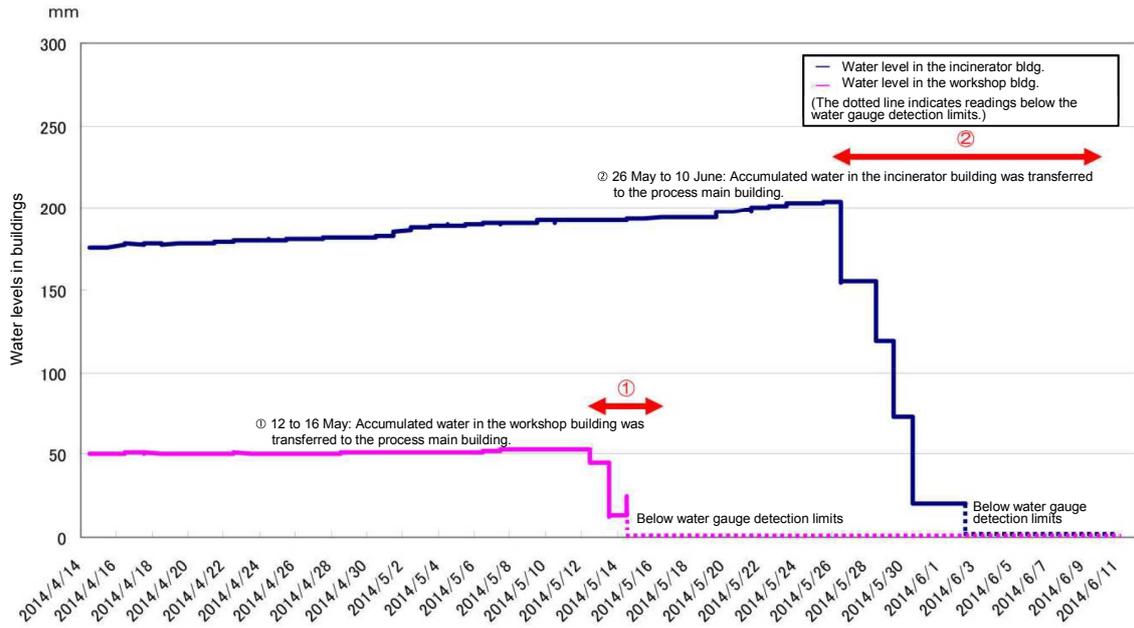
**Figure 2 Accumulated water level in the incineration building (extracted from the TEPCO report)**

- (i) The accumulated water levels did not change during the period between the confirmation of the accumulated water in the incineration building and the start of the transfer of the water (refer to Figure 2).
- (ii) No significant change was observed in the analysis results of the sub-drain water around the incineration building during the period between the confirmation of the accumulated water in the incineration building and the completion of the transfer of the water (refer to Figure 3).
- (iii) The sub-drain water levels around the incineration building were higher than the level of the accumulated water transferred to the incineration building (refer to Figure 4).

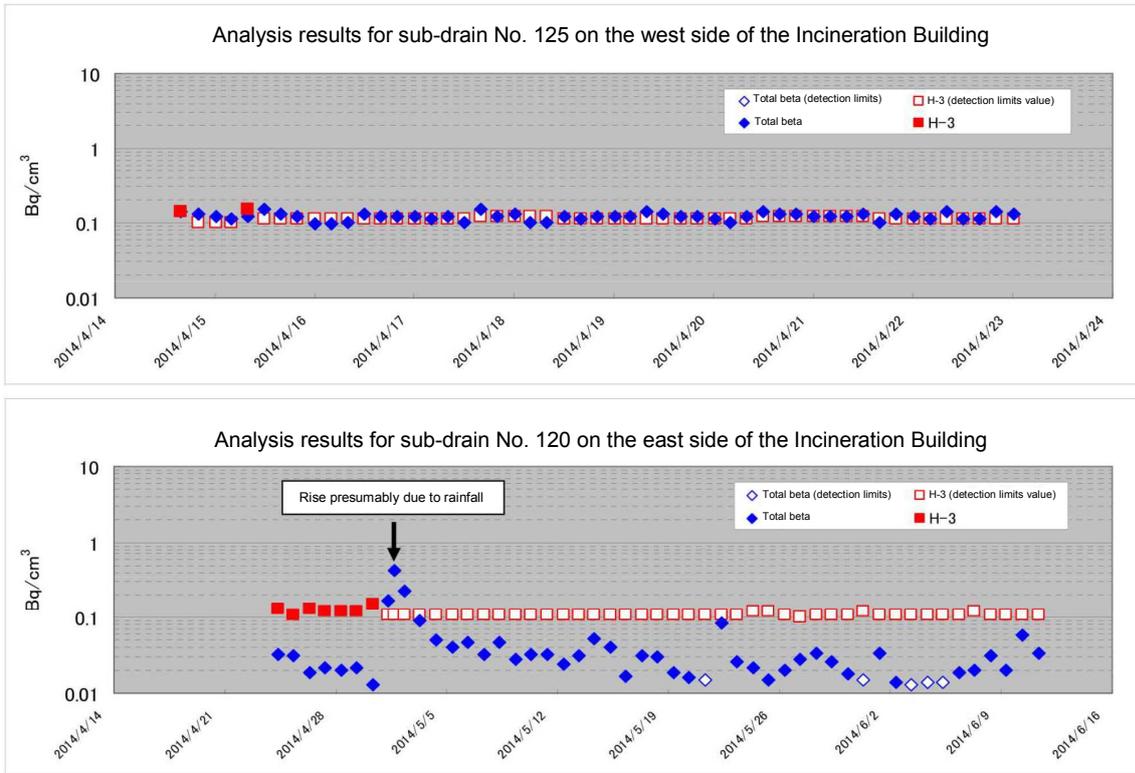
**Figure 3 Analysis results for sub-drain water from around the incineration building (extracted from the TEPCO report)**

Both the nuclide analysis results and the fact that the accumulated water in the incineration building did not exceed the sub-drain water level indicate that the accumulated water did not leak outside the building. Based on this determination, the NRA concludes that there has been neither environmental contamination that raises any concerns about effects on health or the environment nor exposure leading to concern.

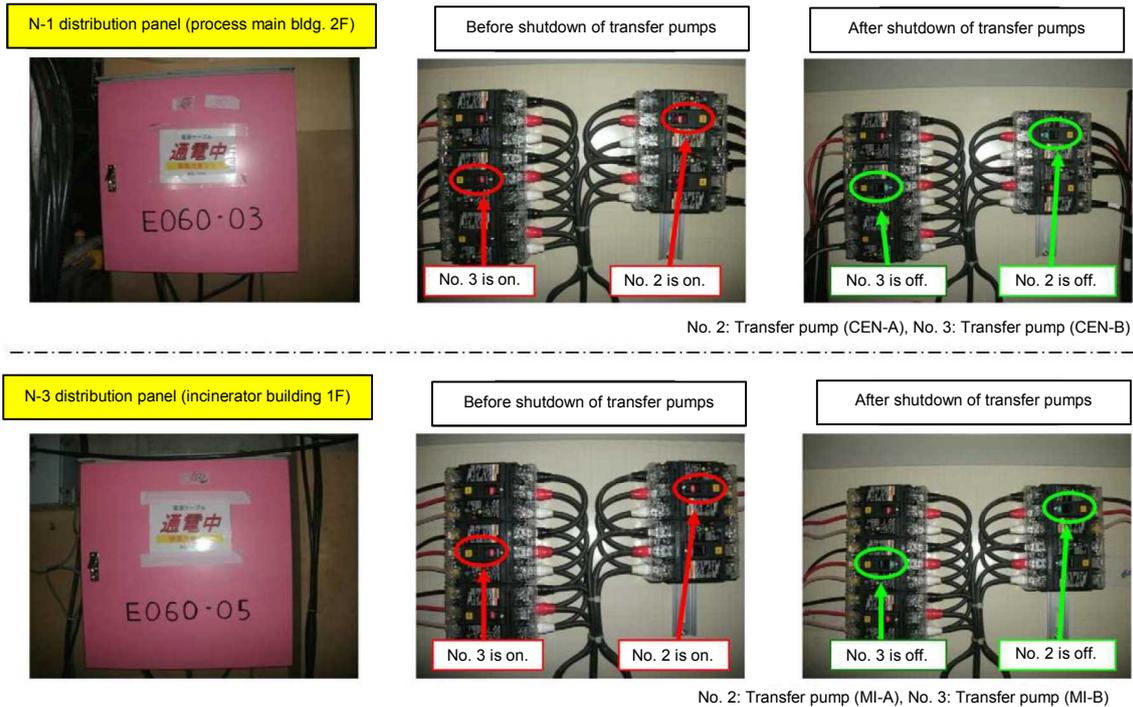
**Figure 5 Distribution panels accommodating circuit breakers for transfer pumps (extracted from the TEPCO report)**

It is highly likely that the circuit breakers for the transfer pumps mounted on the N-1 distribution panel in the process main building and the N-2 distribution panel in the incineration building were closed by mistake during restoration after the work related to shutdown of the power distribution panel (C system) in the process main building, which was conducted on 20 March 2014 (refer to Figure 5). This mistake has four potential causes.

- (i) Workers threw the circuit breakers, referring to the document, including the load list and skeleton diagram. However, it did not contain information to ensure confirmation and recording of work locations and results.
- (ii) The power distribution panel had multiple circuit breakers that had been assigned numbers but were not identified by load equipment names or other means.
- (iii) There were no records of the operations thrown with the circuit breakers to shut down the power distribution panel (C system).

- (iv) Despite installation of some lighting equipment, the work environment (illumination) around the circuit breakers was dimly lit, making the circuit breaker numbers difficult to recognize for the worker.
- (3) Survey on the power system structure that permitted water transfer to start when the circuit breakers were closed

- (i) Countermeasures against mistakes in operation
  - Identification labels (for example, indicating load equipment names) were added to the power distribution panels, and skeleton diagrams were made available near the power distribution panels (at 770 locations). The power distribution panels supplying power to particularly important facilities<sup>1</sup> are now subjected to PTW<sup>2</sup> or other reviews to ensure the management of operating results, in addition to labeling (for example, indicating load equipment names) the power distribution panels.

- The work environment's lighting has been improved (in the process main building and elsewhere<sup>3</sup>).
  - To prevent workers from accessing the facilities without permission, the power distribution panels, control panels, and control boards are kept under lock (401 keys had been locked; this time, 391 keys were additionally locked as of Dec? 2014)
