Evaluation of the report by Tokyo Electric Power Company regarding the leakage from a connection valve between A5 tank and A6 tank in the G4 South Tank Area at the Fukushima Daiichi Nuclear Power Station

Nuclear Regulation Authority, Japan
17 June 2015

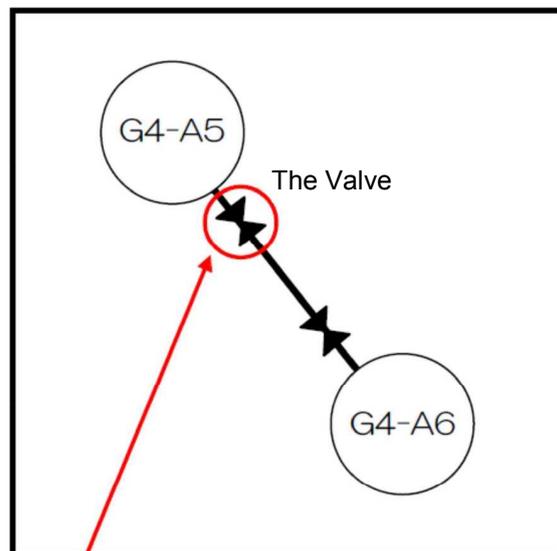
Figure 1 Location of the connection valve that caused the leakage (extracted from the TEPCO report)

Location of the Valve

Location of the leakage

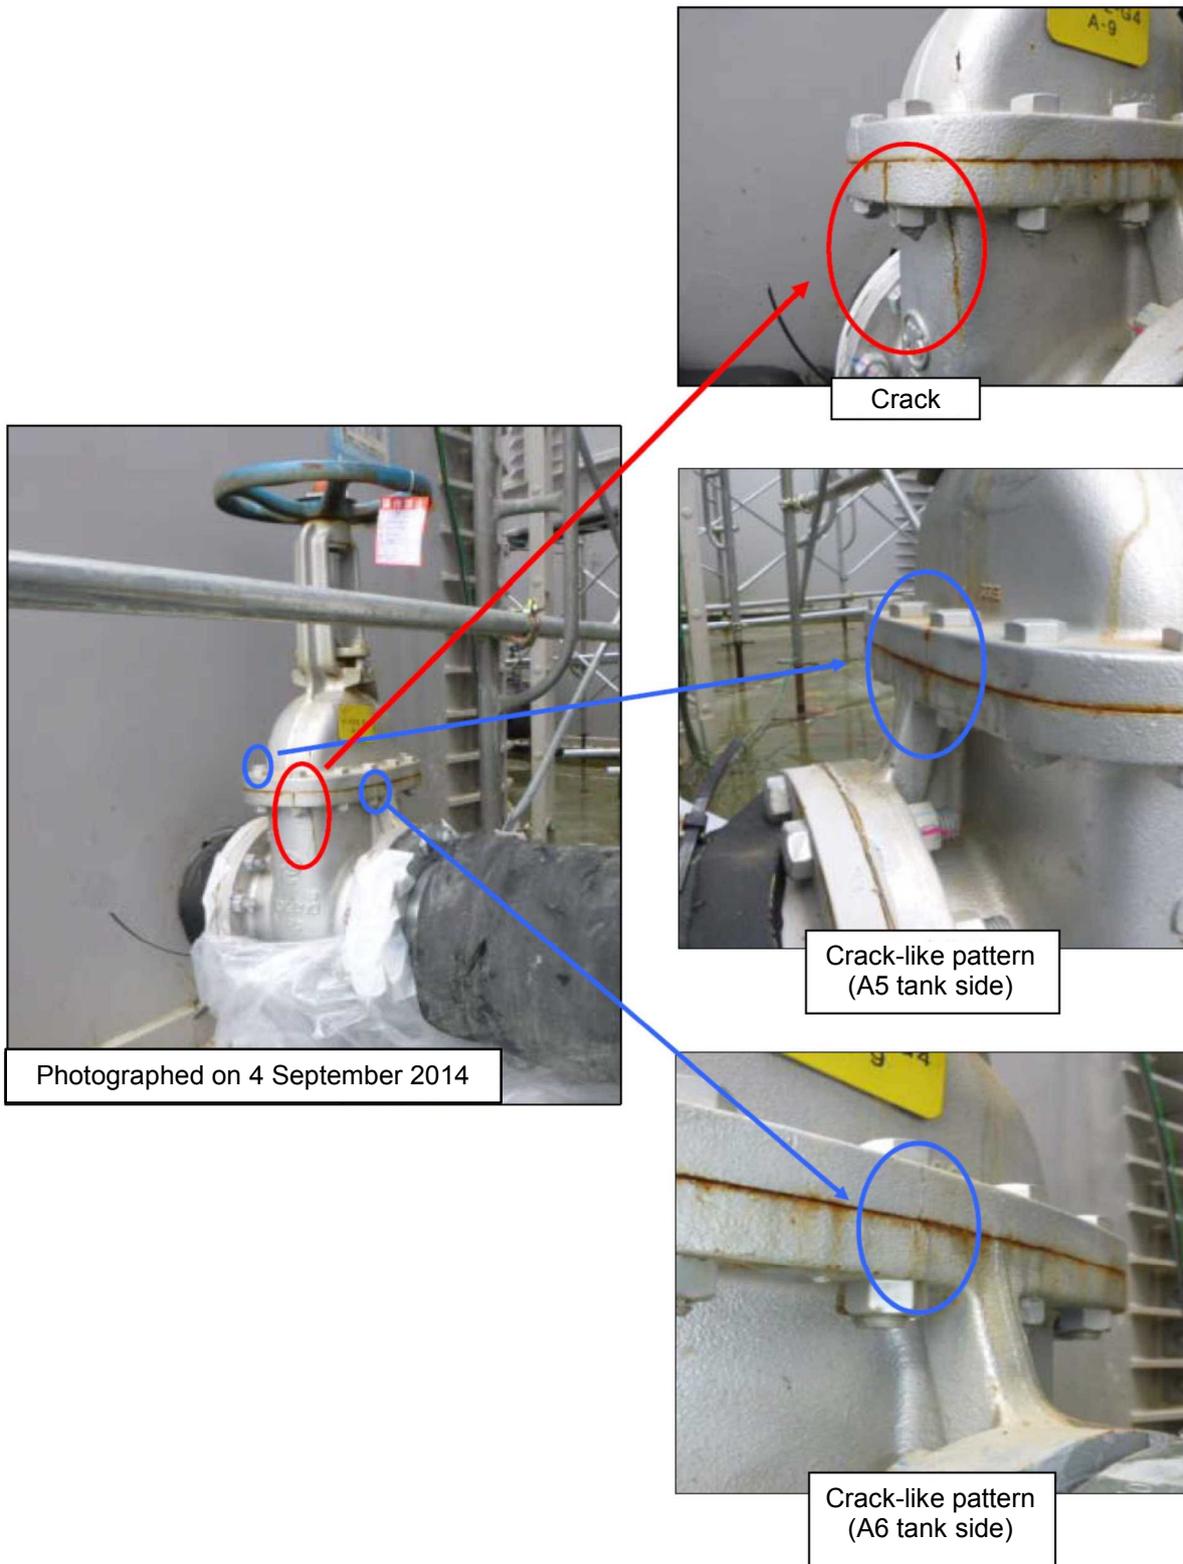
Figure 2 Appearance of the Valve (extracted from the TEPCO report)

Appearance inspection results

The Valve that produced the through crack was replaced with another valve of the same type on 13 September 2014. The same type of valves on the RO-concentrated water lines outside the dikes and inside the dikes of contaminated water tanks was visually inspected by removing thermal insulators from 26 September to 13 November 2014, and no problems were found.

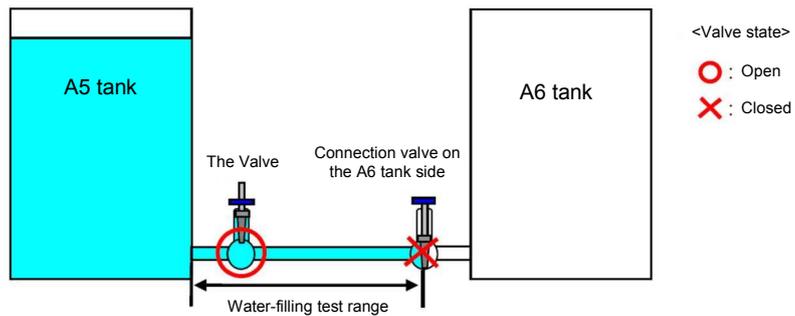
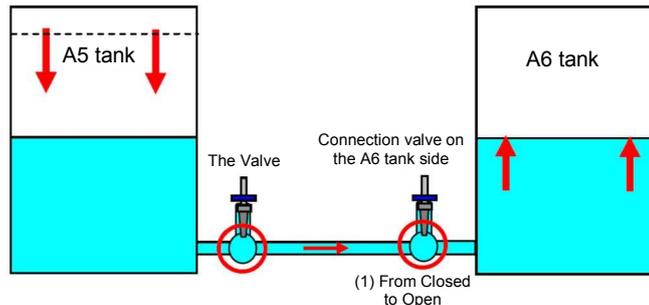
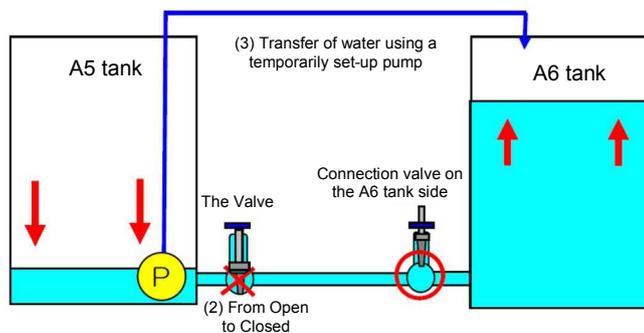
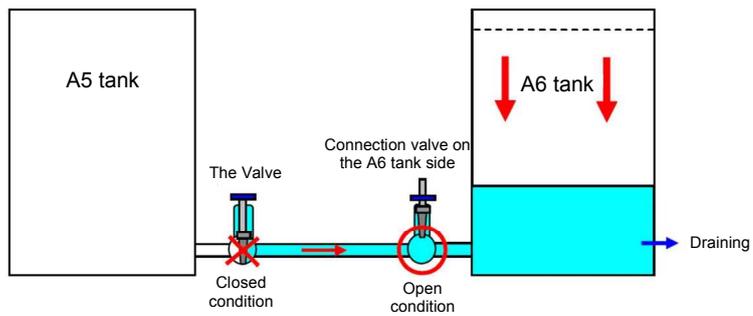
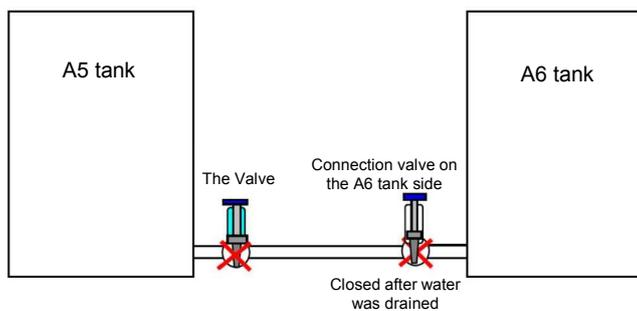
Figure 3 Leakage from tanks (extracted from the TEPCO report)

It was found that the Valve was closed during a draining of the connection pipes following a water-filling test for A5 and A6 tanks in November 2013. As a result, the sealed chamber remained filled with filtered water (refer to Figures 3 and 4). Despite the fact that thermal insulators were installed to the Valve and the connection pipe, due to the close proximity of the Valve to the A5 tank, they were virtually exposed to outside air via the tank (refer to Figure 4).

Water-filling test condition of the connection pipes including the Valve (12 to 13 November 2013)

Transfer of filtered water from A5 tank to A6 tank (using water head pressure)

Transfer of water from A5 tank to A6 tank using a temporarily set-up pump

Condition of A6 tank during the draining procedure

Condition of A6 tank after the draining procedure (Filtered water is remaining in the sealed chamber.)

Related departments were instructed to inscribe in their Testing and Construction Work Manual, the procedures for draining the sealed chamber of valves when draining the connection pipes after conducting water filling tests for contaminated water tanks and connection pipes.

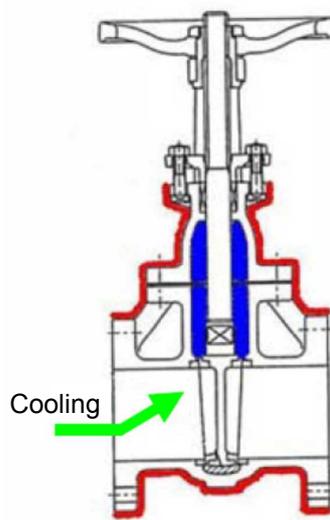
Figure 4 The sealed chamber of the Valve and cooling condition
(extracted from the TEPCO report)

The number of days when the minimum temperature of the outside air within the Nuclear Power Station site marked below-freezing points between late December 2013 and the end of March 2014 amounted to 61 days, out of which 4 days recorded -5°C or lower. Notably, from around 22:00 5 February 2014 to around 5:00 the next morning, the outside air temperature was constantly -5°C or lower. Because of such low temperatures, it is presumed that the sealed chamber of the Valve cooled from the inside, and the filtered water remaining inside the sealed chamber froze and its increased volume caused the through crack.

The sealed chamber was exposed to outside air that came in through the air bleeder tube of A5 tank, and the chamber was likely cooled from inside of the valve. Due to this condition, the thermal insulator attached on the outside of the Valve did not work effectively.

The A6 tank side of this sealed chamber was not directly exposed to outside air because the connection valve on the A6 tank side was in the closed position.

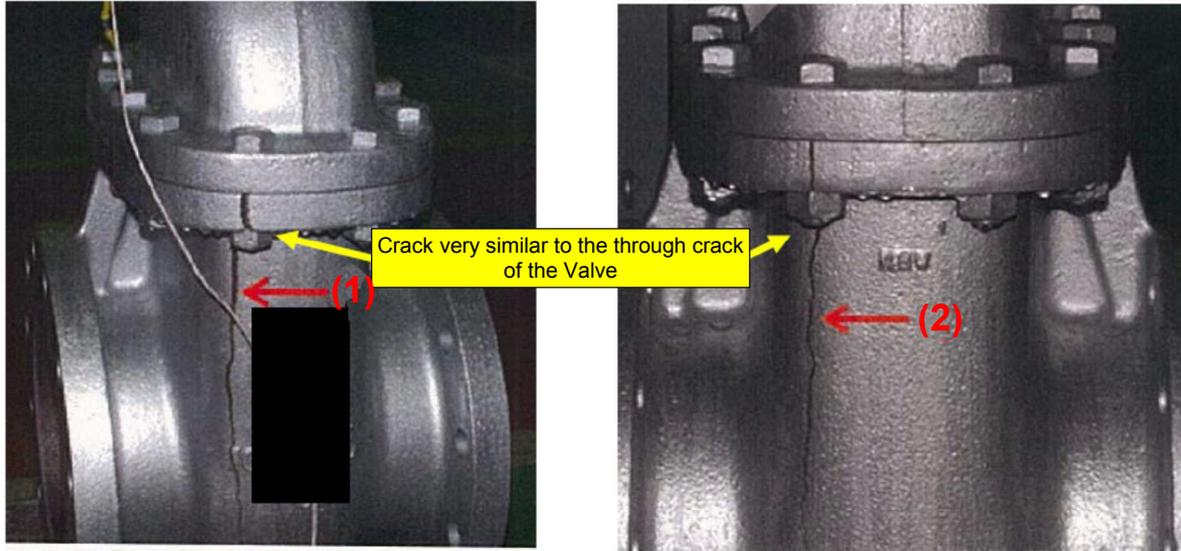
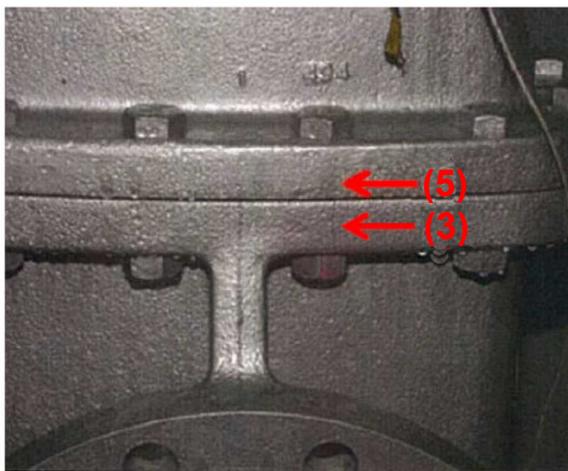
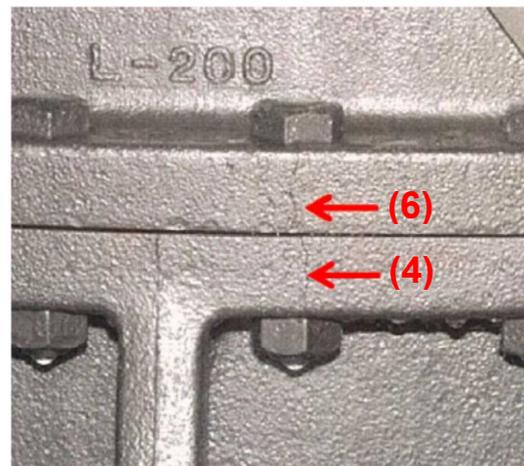
Figure 5 Results of a test that reproduced generation of through cracks due to freezing (extracted from the TEPCO report)

The manufacturer of the Valve investigated past similar incidents, and as a result, found an incident where liquid remaining in the sealed chamber inside the Valve box froze and its increased volume applied excessive stress that generated a crack. A valve of the same type with its sealed chamber full of water was tested by leaving it at an ambient temperature of -10°C . When the temperature on the surface of the Valve box reached approximately -5°C (around 6 hours and 20 minutes from the start of the test), a crack resembling the through crack which caused this incident appeared (refer to Figure 5).

Cracks were found at six points (1) to (6).

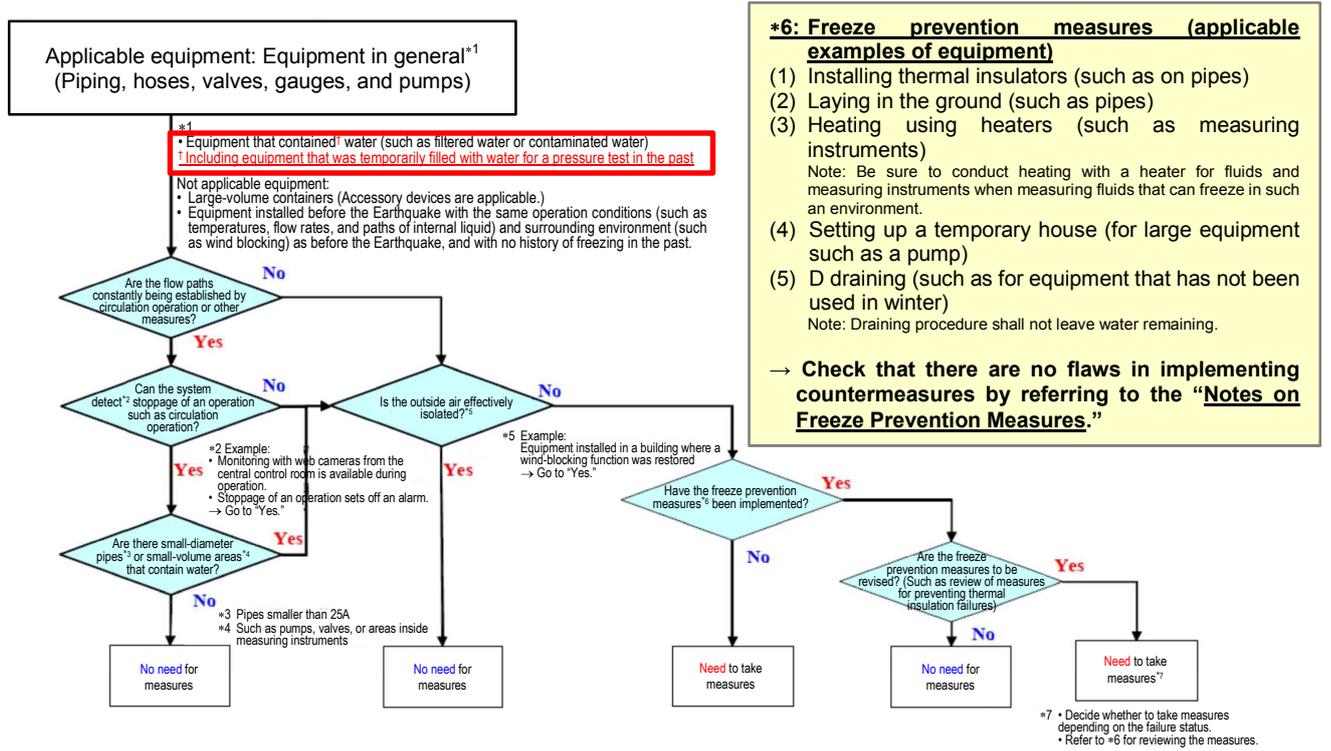
Figure 6 Flow chart for implementing the freeze prevention measures
(extracted from the TEPCO report)

: This point has been reflected in the guidelines as countermeasures for this incident.
(The words in red were added.)

To ensure that measures are taken for similar valves, which have sealed chambers, the outline of this incident was included in *the Implementation Guideline for Freeze Prevention Measures*, one of the TEPCO's guidelines, which was set on 27 November 2014. The guideline instructs the selection of those pieces of equipment that require freeze prevention measures. The revision also specified the removal of remaining water annually in accordance with the flow chart for implementing freeze prevention measures that apply to equipment containing water (such as filtered water or contaminated water) and equipment that contained water in the past (refer to Figure 6).
