Evaluation of the report by Tokyo Electric Power Company regarding an alarm set off from a side ditch effluent radiation monitor at the Fukushima Daiichi Nuclear Power Station

Nuclear Regulation Authority
September 2, 2015

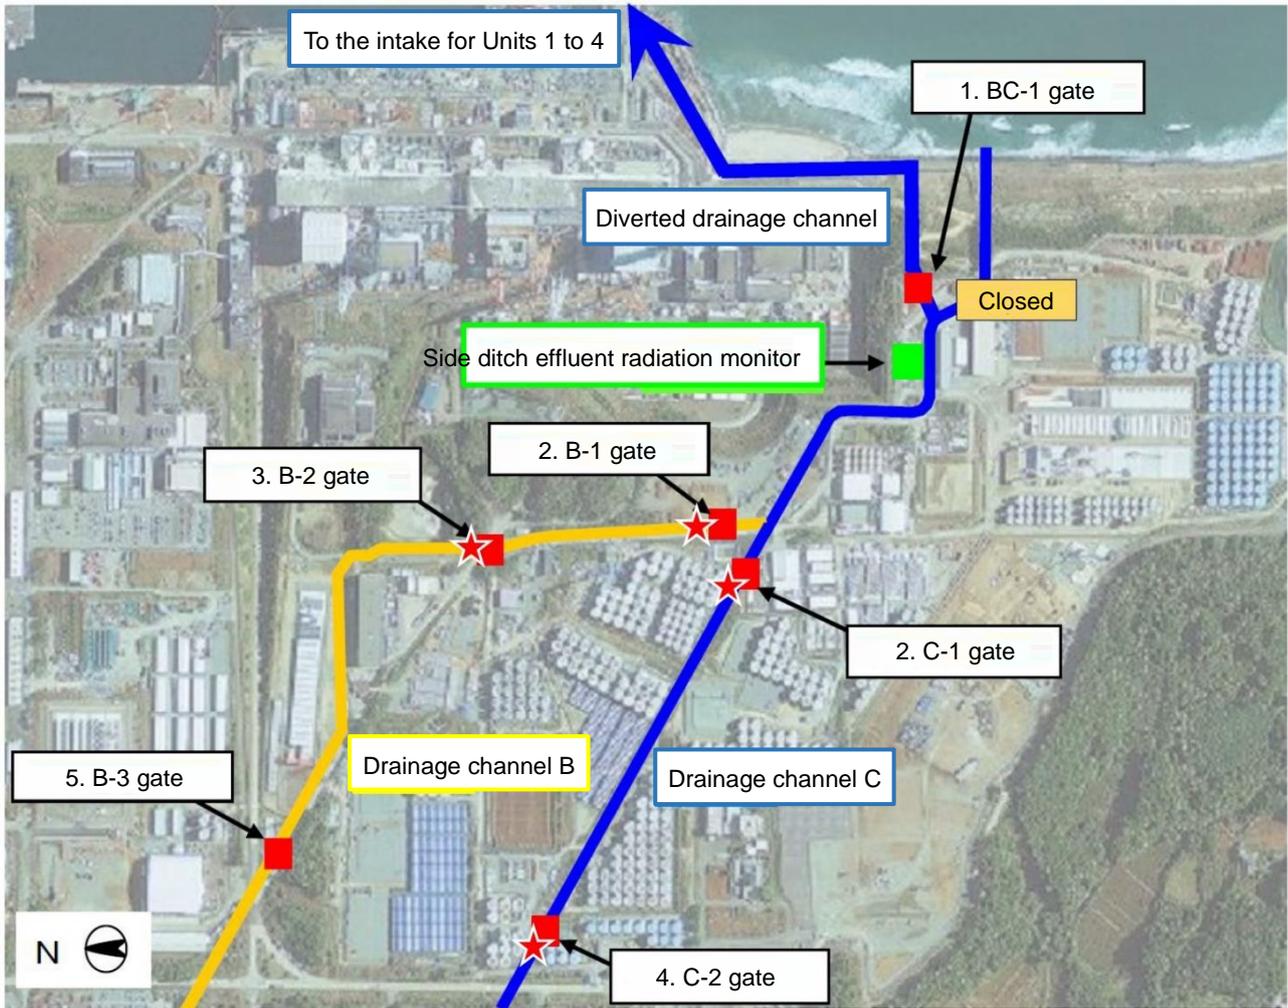
Figure 1. Layout drawing of drainage channels B and C, side ditch effluent radiation monitor and gates (excerpt from TEPCO's final report)

★ Locations where the installation of simple radiation detectors is scheduled (four locations)

【Clock times when the gates of drainage channels B and C closed after the event occurred】

| <ol style="list-style-type: none"> 1. BC-1 gate closed at 11:35 2. B-1 and C-1 gates closed at 11:55 3. B-2 gate closed at 12:07 4. C-2 gate closed at 12:24 5. B-3 gate closed at 12:47 |

- Lighting equipment and pumps will be improved with gate closure and effluent collection work taken into account.
- To enable early detection of contamination, simplified radiation detectors are scheduled to be installed at four locations of drainage channels B and C (see Figure 1).

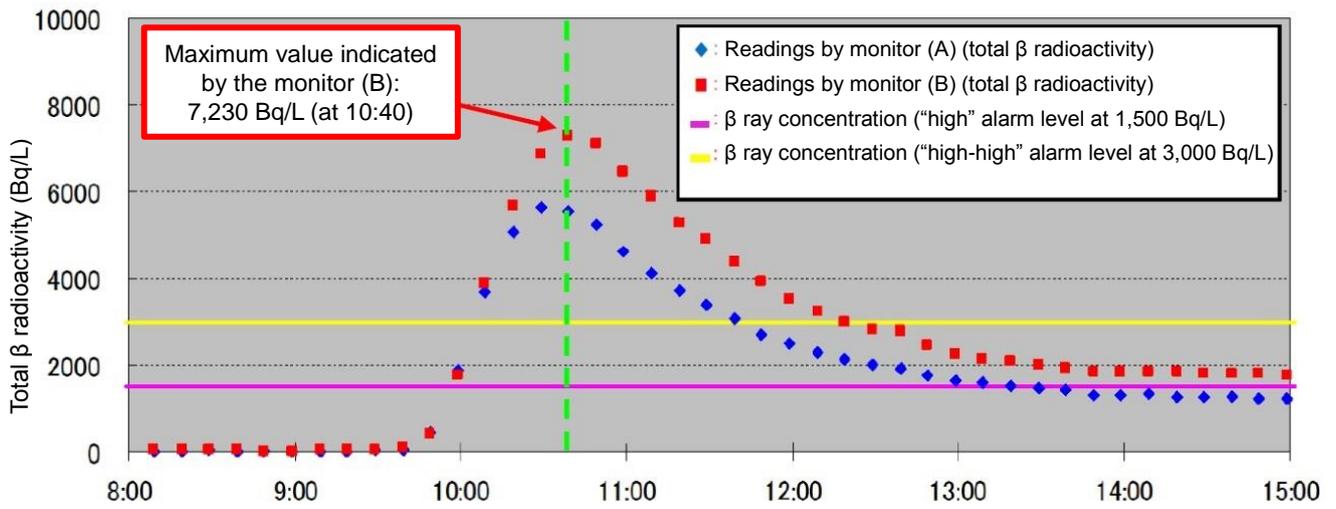
Figure 2. Total beta nuclide radioactivity concentrations measured by the side ditch effluent monitor before and after the alarm set off (excerpt from TEPCO's final report)

At around 10:00 on February 22, 2015, a “high” alarm indicating an increase in the radioactive concentrations of total β nuclides*¹ (alarm set at 1,500 Bq/L) was set off from a side ditch effluent radiation monitor downstream of drainage channel C (hereinafter referred to as “the monitor”). Subsequently at 10:10, a “high-high” alarm (set at 3,000 Bq/L) was set off.

In response to the alarm, BC-1 gate, which was located at the lowermost stream of the drainage channel C, was closed at 11:35. By 12:47, other five gates installed at drainage channels B and C were closed. After peaking at around 10:40, the readings of the monitor began to decrease. By 12:20, the “high-high” alarm was cancelled. At around 22:00, the radioactive concentrations of total β nuclides decreased to normal fluctuation range. After water in drainage channels was collected using vacuum trucks, BC-1 gate was opened at 3:50 on February 23 and other five gates were opened in series by 5:23.

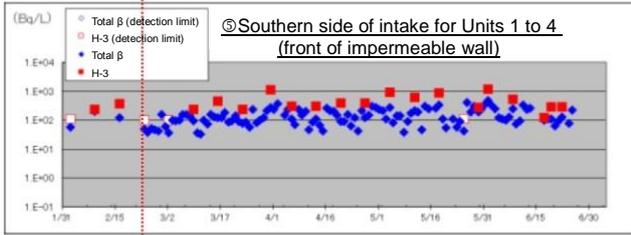
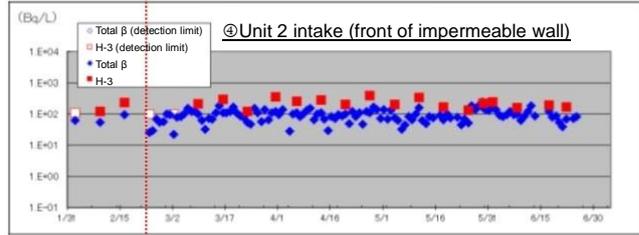
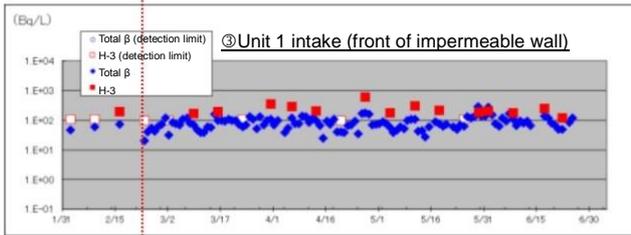
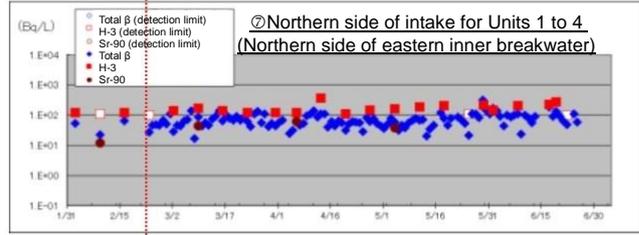
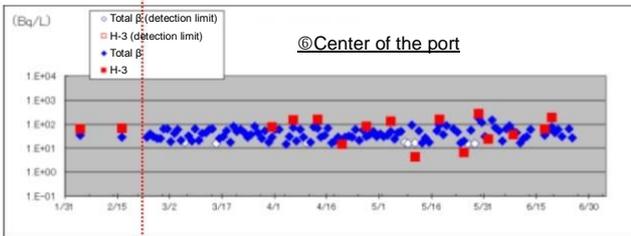
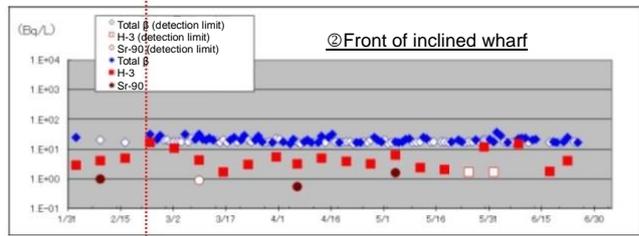
Figure 4. Results of analyzing radioactivity concentrations in the seawater in the port (excerpt from TEPCO's final report)

Because the results of monitoring the inside of the intake channels for Unit 1 to 4 and port showed that the radioactive concentrations of the total β nuclides inside them were within normal variation range and did not show significant fluctuation (see Figure 4), the NRA thinks that the contribution of the outflow of the high radioactive concentration effluent to the radioactive material concentration in the port was small (it was reported that the radiation level of the radioactive materials having flowed out into the port this time was estimated at about 1.7×10^8 Bq for ^{90}Sr , while the radiation level of ^{90}Sr that has been daily flowing into the port from the bank protection of the unclosed section of the seaside impermeable wall, estimated by the 33th Committee on Supervision and Evaluation of the Specified Nuclear Facilities on March 25, 2015, is 2.7×10^9 Bq/day).

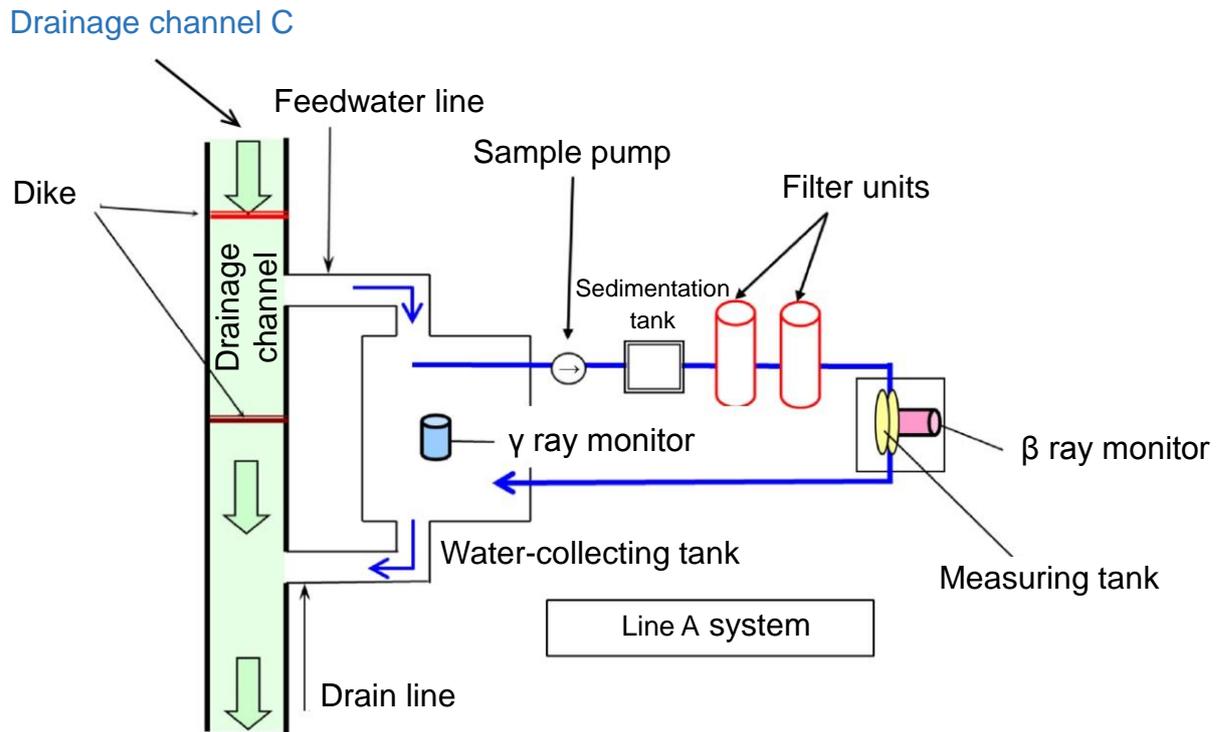
Figure 5. Outline of the side ditch effluent radiation monitor (excerpt from final report by TEPCO)

With regard to the TEPCO's estimate of the radiation level of the radioactive materials that outflowed into the port, namely 4×10^8 Bq for total β nuclides (about 1.7×10^8 Bq for $^{90}\text{Sr}^{*2}$), TEPCO has calculated the radiation level using the readings of the monitor and flow rates measured at drainage channel C while taking into account 30-minute delay caused by a sedimentation tank, etc. (see Figure 5). Therefore the NRA has concluded that this estimate is valid.

Monitor Line B is placed at the downstream of the drainage channel similarly to LineA system, thus redundant.
