# Evaluation of the Tokyo Electric Power Company's Report Regarding Tank Area In-Dike Rainwater Leakage at the Fukushima Daiichi Nuclear Power Station

Nuclear Regulation Authority (NRA)

March 30, 2016

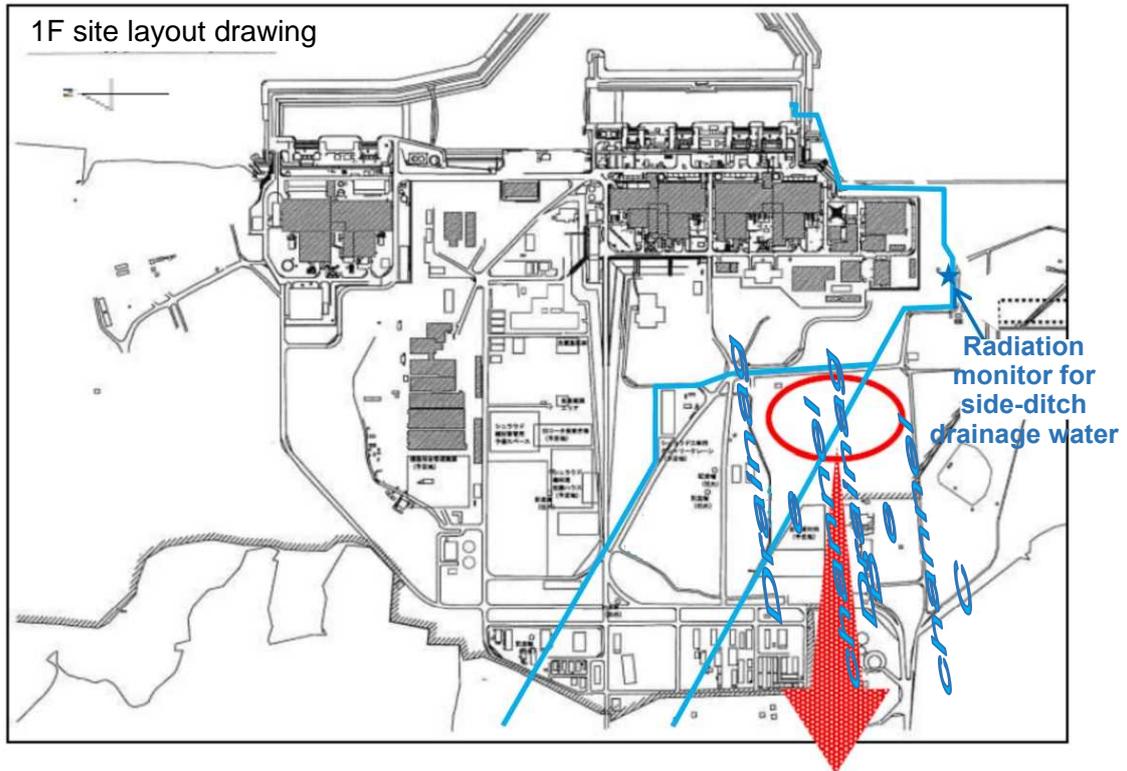
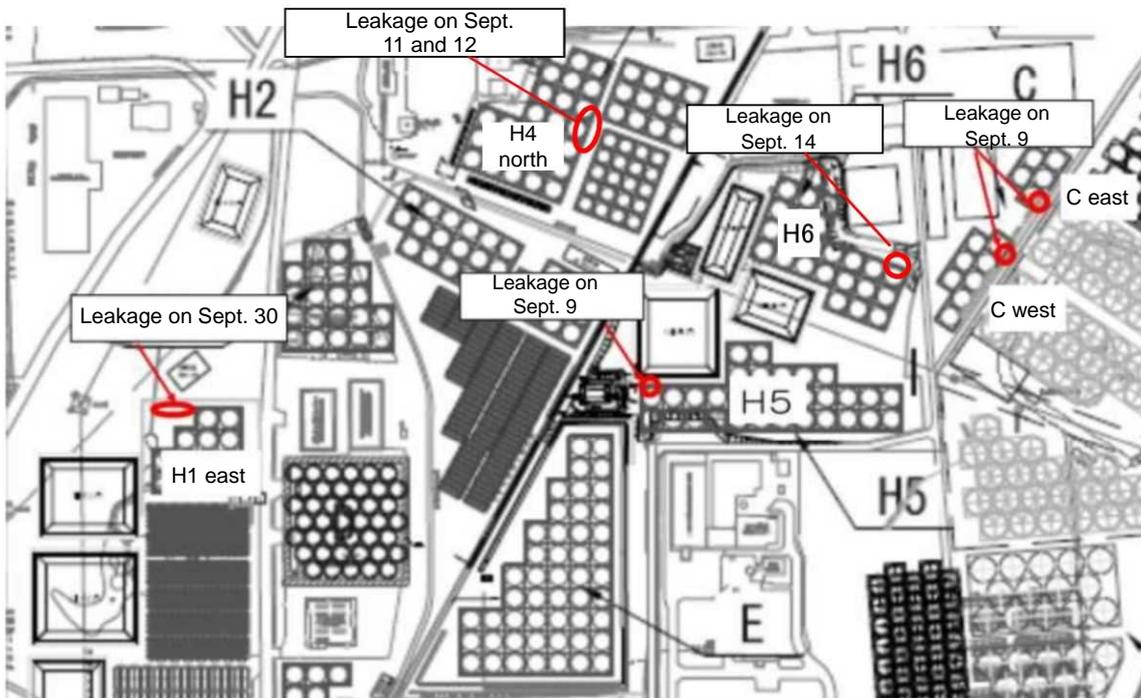
Figure 1. Layout drawing of tank area where rainwater in dike leaked (excerpt from the TEPCO report, with partial revision)

At around 12:10 on September 11, 2015, a subcontractor employee who was patrolling the contaminated water storage system (hereinafter referred to as “tank patrol”) found rainwater (hereinafter referred to as “in-dike rainwater”) leaking from a joint of the H4 north tank area foundation’s circumferential dike (hereinafter referred to as “inner dike”). Also at around 17:35 on September 14, 2015, a contractor employee found in-dike rainwater leaking from the H6 tank area inner dike. In each area, work for stopping the leakage using water-stopping material and temporary measures such as water level reduction by transferring the in-dike rainwater were carried out. As a result, the leakage stopped. The locations and situations of the leakage are summarized in Figure 1 and Table 1.

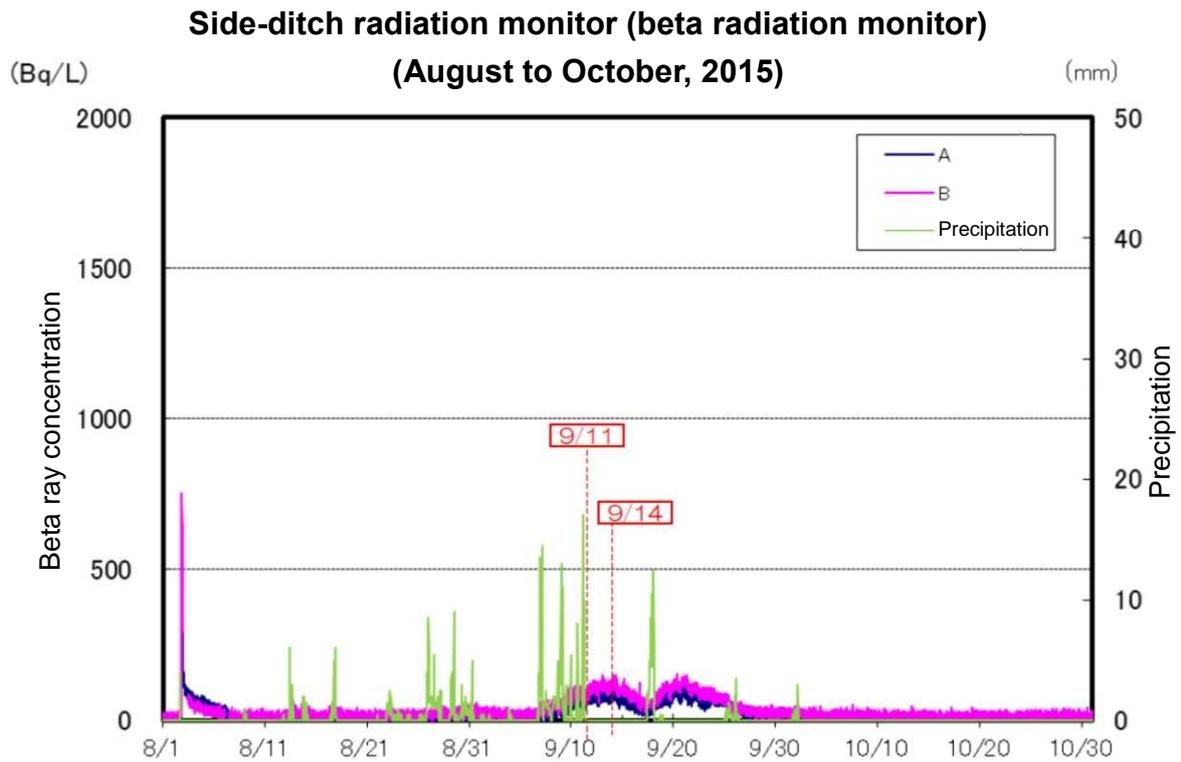
(a) Radiation monitor readings of side-ditch drainage water (excerpt from the TEPCO report)

did not show a significant difference before and after the leakage, no environmental impact is considered to have occurred (see Figure 2).

Since the leaked water did not reach the drainage pit, it was judged that leaked water outflow into drainage channel did not take place. In addition, the readings of side-ditch drainage radiation monitor installed in drainage channel C did not show any significant variation before and after the leakage, thus there was no impact on the environment.

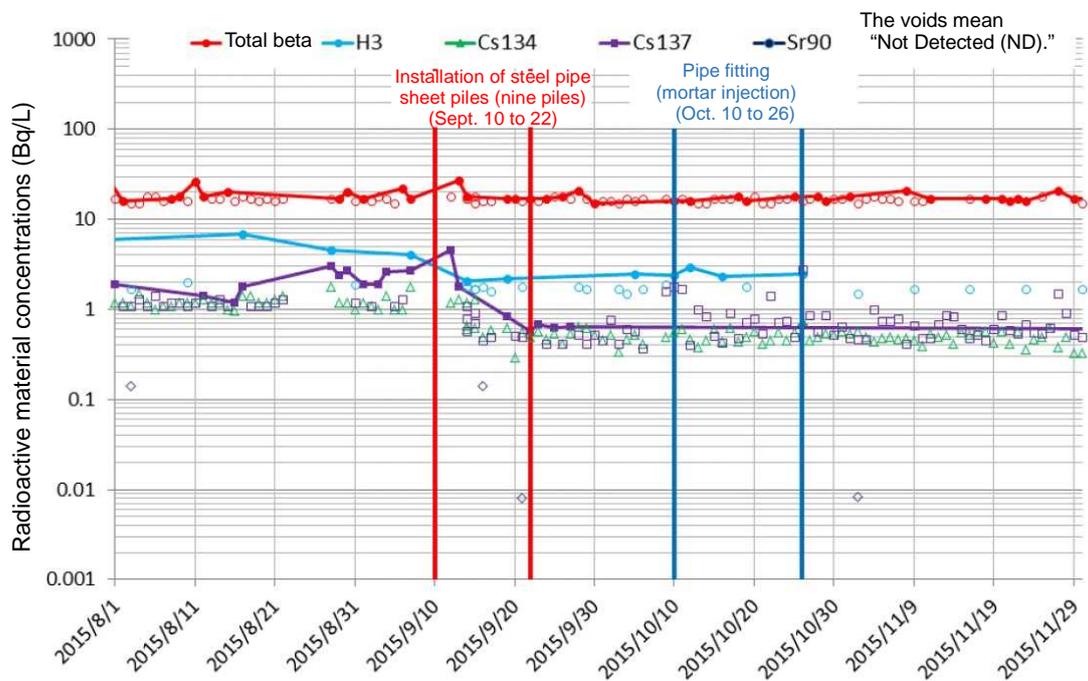
(b) Results of seawater monitoring at the port entrance (prepared by the Secretariat of the NRA)

As a result of analyzing the readings from a side-ditch drainage radiation monitor installed in drainage channel C, which is downstream of the H4 north and H6 tank areas, as well as radioactivity at the port entrance, no significant total beta nuclide concentration difference before and after the leakage indicating leaked water outflow into the outside of the port was observed (see Figure 2). Therefore, no seawater contamination is considered to have occurred that posed health and environment concerns.

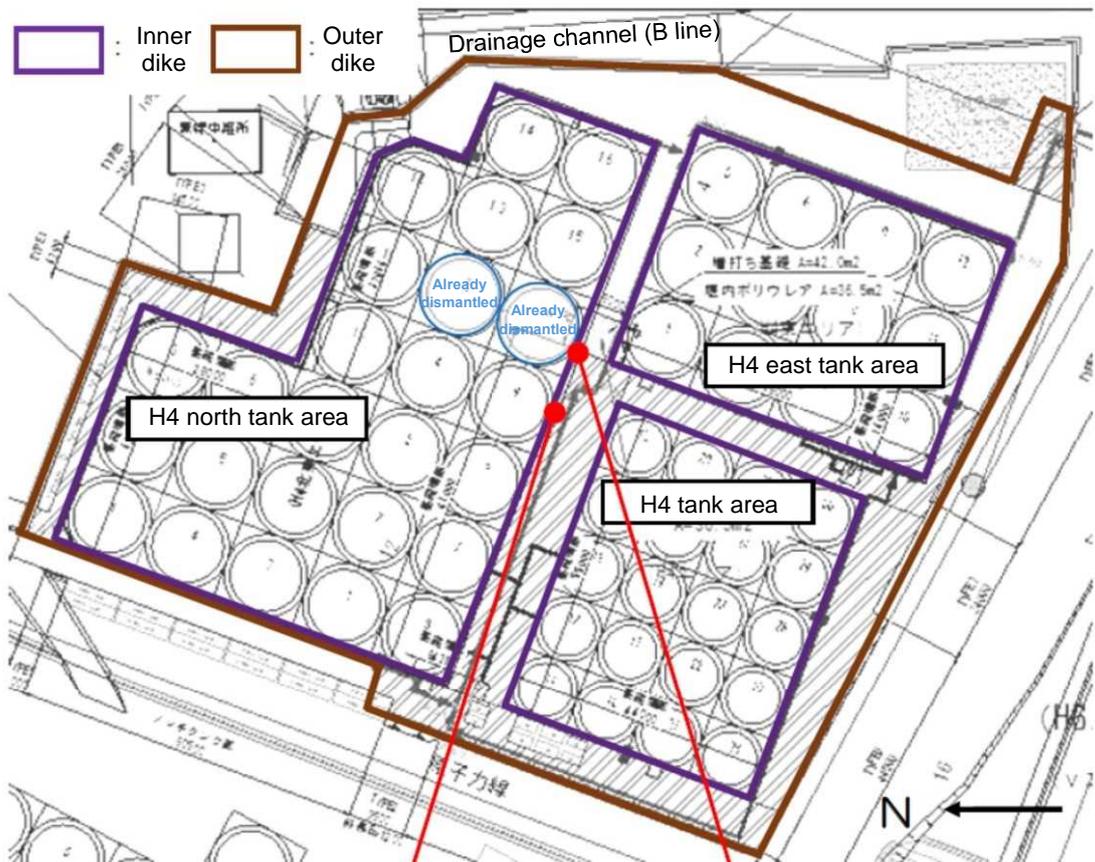
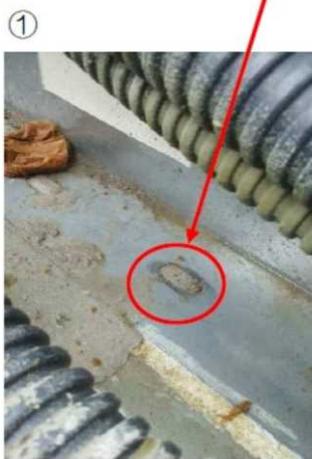
**Figure A. Situation of leakage at the H4 north tank area (excerpt from the TEPCO report)**

On August 19, 2013, in response to RO concentrated water leakage in H4 north tank area, a structure for immediately making the concrete inner dike taller by adding a steel dike was adopted. The structure had a joint and mounting bolt sections between the concrete dike and the steel dike, a factor which increased the risk of water leakage from them.

It is estimated that leakage from the H4 north, H6 and H1 east tanks' areas was due to sections where the seepage prevention effect of polyurea that was sprayed entirely over the floor and inner surfaces of the inner dike was inadequate, from which in-dike rainwater seeped through the steel dike and leaked out from sections with inadequate water-stopping work.

<Leakage found on Sept. 11>  
 ① Pencil-size leakage occurred from the bolt hole.  
 \* No damage or dent was found.

- ① A measure applied to the elevated inner dike's joint and mount bolts  
Polyurea will be sprayed to both the inside and outside of the inner dike boundary.

- ① A measure applied to the elevated inner dike's joint and mount bolts  
Polyurea will be applied to the inner dike boundary from outside, which will enhance water-stopping effect and reduce the risk of leakage.

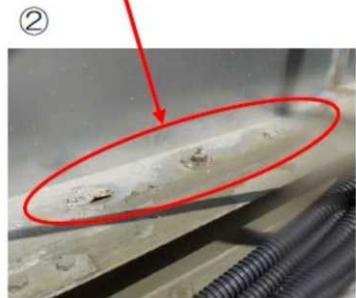
<Leakage found on Sept. 12>  
 ② Leakage at a rate of one drop per 10 seconds from the bolt section  
 \* No damage or dent was found.

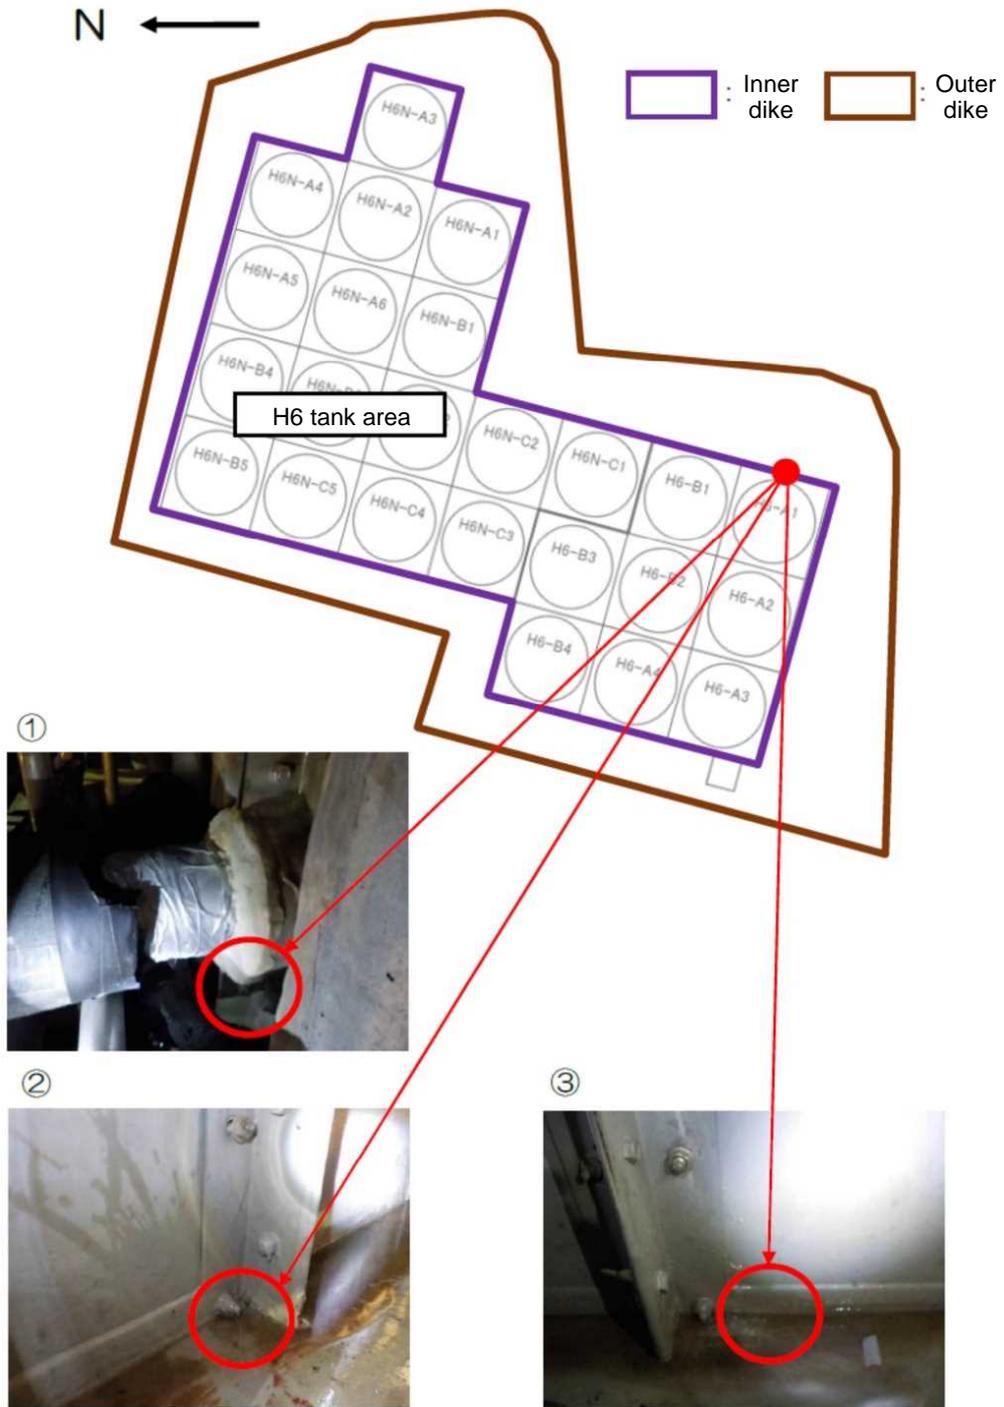
**Figure B. Situation of H6 tank area leakage  
(excerpt from the TEPCO report)**

When installing pipes after the inner dike was installed, it was necessary to quickly complete the pipe installation to avoid the stagnation of contaminated water treatment, and therefore a structure where pipes penetrated the inner dike was adopted. The construction started without clarifying detailed specifications of some penetrations, thus the validity of the structure was not checked using design-stage drawings.

<Leakage found on Sept. 14>

①: Leakage from a pipe penetration of steel dike

② and ③: Leakage from these two joints

(Leak level is unknown for any of these cases.)

\* No damage or dent was observed.

- ② Measures applied to the inner dike's pipe penetrations  
Water-stopping material will be applied to the inner and outer surfaces of the inner dike's pipe penetrations and localized water-filling tests will be performed to check for leakage.

- ② Measures applied to the inner dike's pipe penetrations  
Pipe penetrations will be provided with water-stopping means both from inside and outside and localized water-filling tests will be carried out, which will reduce the risk of leakage.
