Evaluation of the report of Tokyo Electric Power Company regarding the leakage from the RO concentrated water storage tank at the Fukushima Daiichi Nuclear Power Station

31 March 2015
Nuclear Regulation Authority, Japan

10 December 2014
Nuclear Regulation Authority, Japan

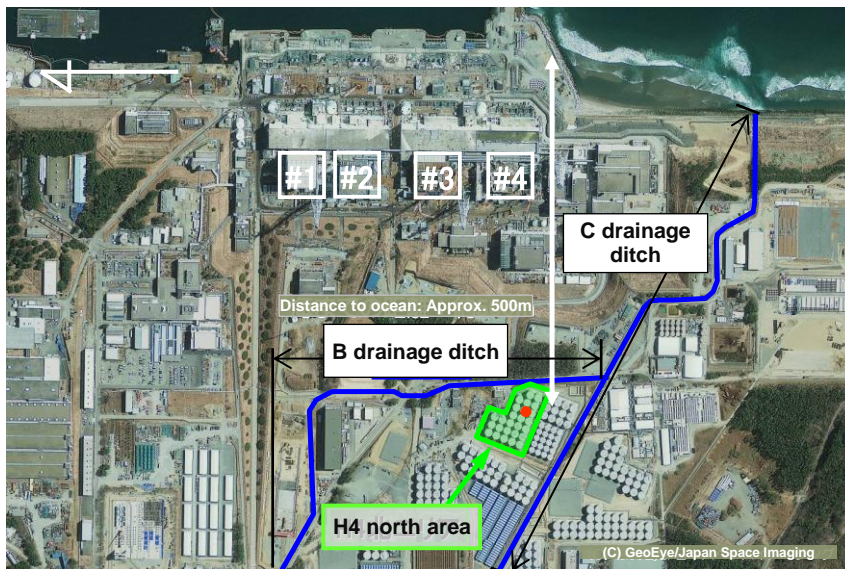
Figure 1 H4 north area^{*2}

Around 9:50, 19 August 2013, a worker patrolling the site of the contaminated water storage facility found that there was an accumulation of water inside and outside of the dike built to surround the RO concentrated water tanks in the H4 north area (refer to Figure 1), and that the water inside of the dike was running outside of the dike from the drain valve of the dike. At the time, the portable dosimeter set off an alarm.

Immediate measures were taken to prevent the spread of the leakage, and to collect the leaked water, which led to the reduction of the water level of No.5 tank of the RO concentrated water tank in H4 north area (hereinafter, referred to as "leaking tank").

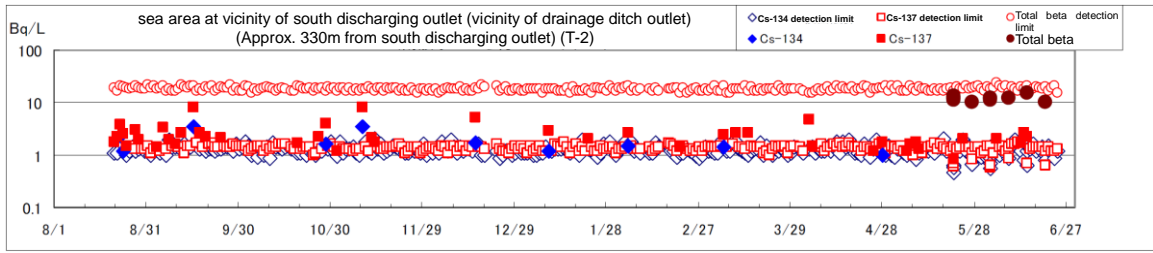
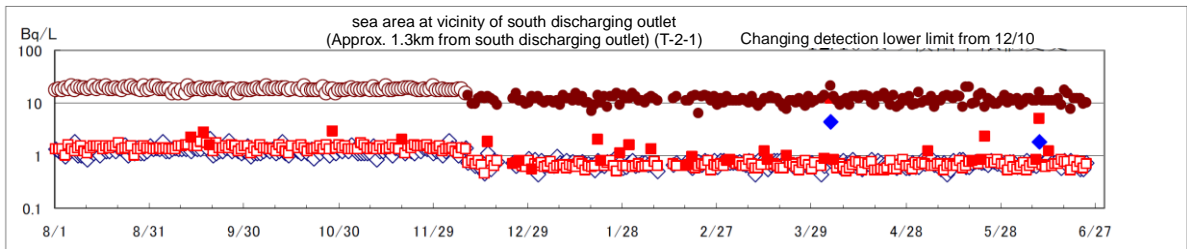
Figure 3 Results of seawater monitoring^{*2}

In terms of an environmental impact, no obvious increase in measurement results of total beta was detected in the seawater monitoring (refer to Figure 2) at the north/south discharging outlets (refer to Figure 3).

There is no obvious fluctuation in the monitoring results at the vicinity of the south discharging outlet (T-2-1) before and after the leakage of the tank. There is no detection of total beta that suggests leakage of the contaminated water leaked from the tank (total beta/radioactive cesium concentration rate is 10^3 to 10^4 (refer to Table 3)) to the ocean at the point T-2 which is the closest to the C drainage ditch after finding leakage.

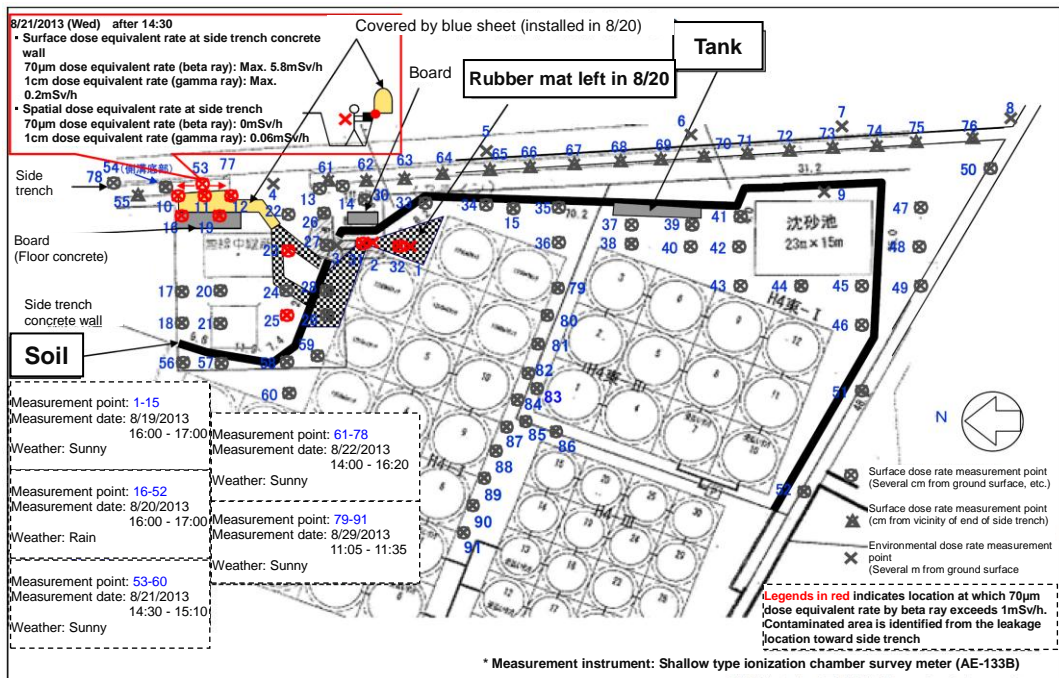
Figure 4 Radiation dose rate survey on ground surface (measurement point)^{*2}
(Table 1 shows inspection results of radiation dose rate)

Figure 4 and Table 1 show the results of radiation dose rate survey of the contaminated ground surface. Figure 5 shows recovery locations.

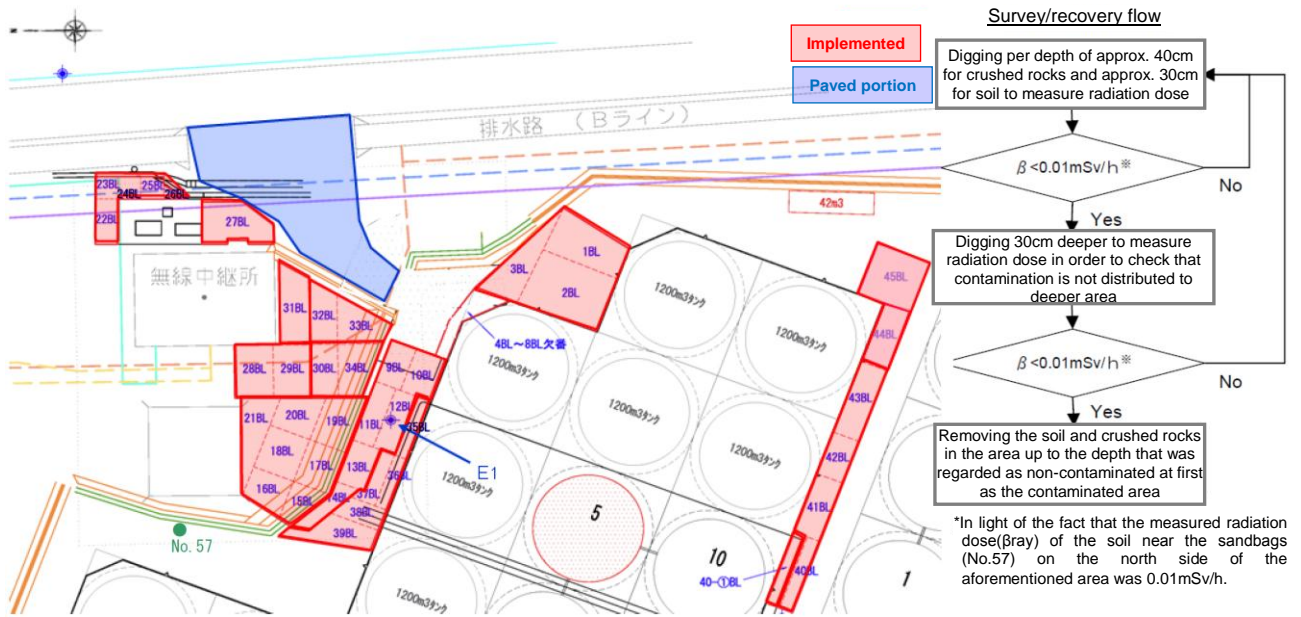
Figure 5 Contaminated soil recovery portion^{*2}

Radioactive strontium contained in the leaked amount (approximately 300m³) is estimated to be 4.5×10¹³Bq, based on evaluations of the water level decrease in the leaking tank (3m). Approximately 80% (3.7×10¹³Bq) of the radioactive strontium contained in the leaked amount was collected by removal of contaminated soils (soil contaminated by radioactive materials with radiation dose rate of the beta ray with 0.01 mSv/h or more). Additional surveys will be implemented to collect the radioactive strontium as much as possible while the replacement of the aforementioned H4 north area tanks are implemented(scheduled to be started from February 2015).

Recollect the contaminated soil such as those beneath concrete foundation of the tank area was planned in accordance with the progress of the replacing work of H4 north tank area.

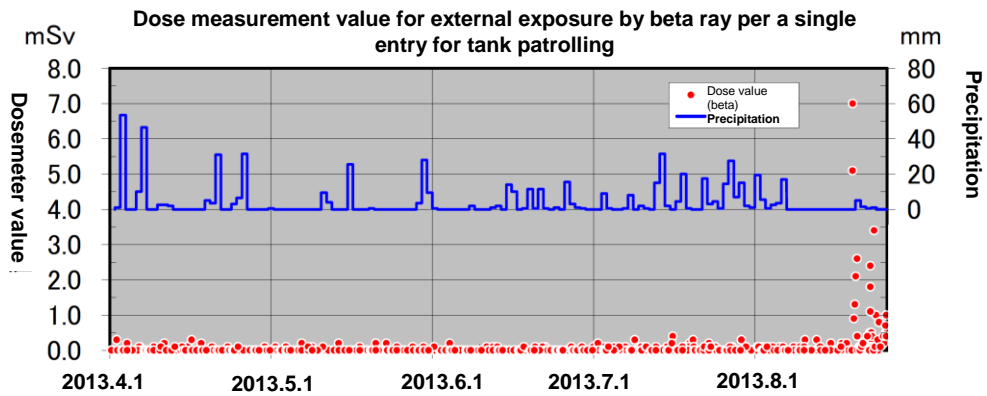
Figure 6 External exposure dose values of beta ray on the workers who patrolled the tanks^{*2}

Figure 6 shows an external exposure radiation dose rate of beta ray on the workers who patrolled the tank around H4 north area.

Equivalent radiation dose to skin caused by effective exposure of radiation dose of the gamma ray and the beta ray to the workers who conducted patrol was evaluated in consideration of higher concentration of the beta ray radiation nuclide in the contaminated water leaked from the tank that is as high as the total beta/cesium concentration rate of 10^3 to 10^4 (refer to Table 2).

leakage. The equivalent radiation dose to skin was well below annual radiation dose limitation of 500mSv although the maximum dose per single entry zone significantly increased. Thus, the NRA evaluates that there is no exposure to concern.

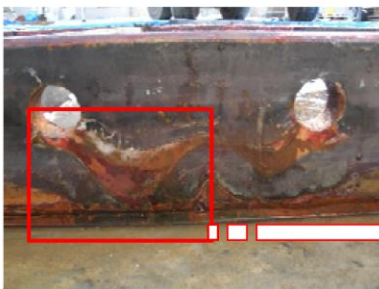
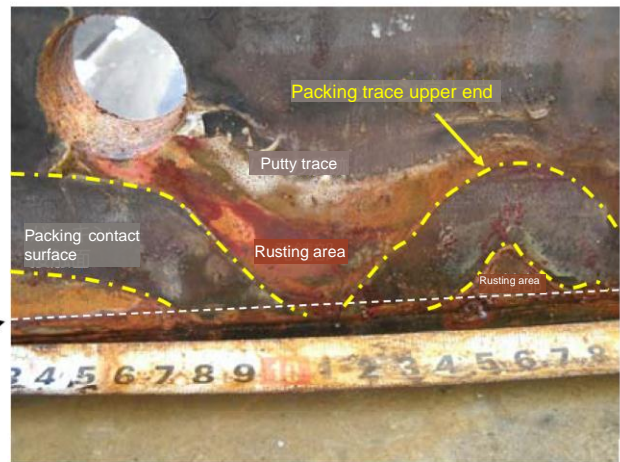
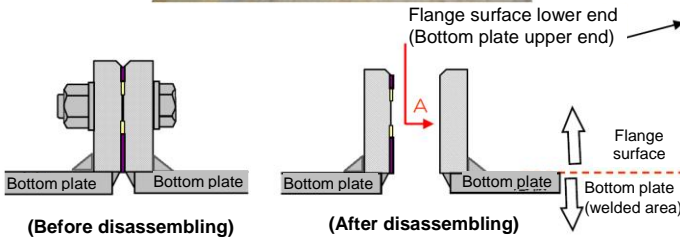
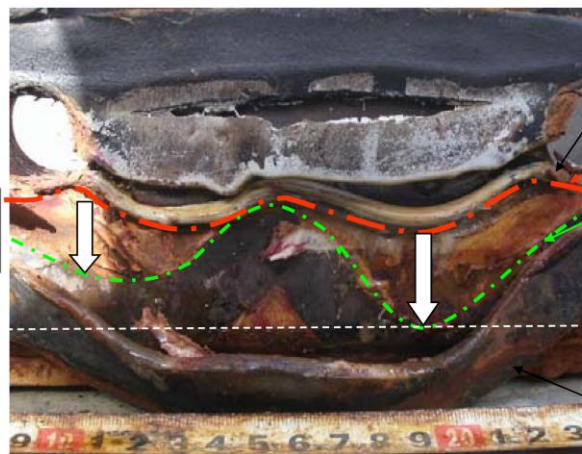
Figure 7 Location of leakage*2

As a result, it was found that the leakage point was located at the discovered protrusion

of packing at the flange section of the tank bottom plate (refer to Figure 7). The assumed cause was estimated to be a reduction of bolt torque to tighten the packing, due to the impact of thermal expansion/shrinking of the flange caused by a subtle waving of the packing at the time of tightening the bolt at the location of the leakage. In addition, it was accompanied with the opening of the lower end of the flange. It is presumed that this led to the protrusion of the packing which shifted downward out of the bottom of the tank due to the inability to resist the water pressure of the tank.

Packing is lowered due to temporal deterioration

Flange type tanks on which the leakage was discovered shall be replaced with welded tanks, and the replacement shall be preferentially applied to the TYPE-1^{*1} on which the leakage was found.

As tentative countermeasures until replacing with welded tanks, the implementation of following measures shall be considered (refer to Figure 8): 1) Waterproofing by caulking, etc. at the bottom of the tank, 2) Filling sealing material underneath the bottom plate, and 3) Filling sealing material at the bottom plate section (inside).
