Evaluation of the report of Tokyo Electric Power Company regarding the leakage from the RO-treated water storage tank at the Fukushima Daiichi Nuclear Power Station

15 April 2015

Nuclear Regulation Authority, Japan

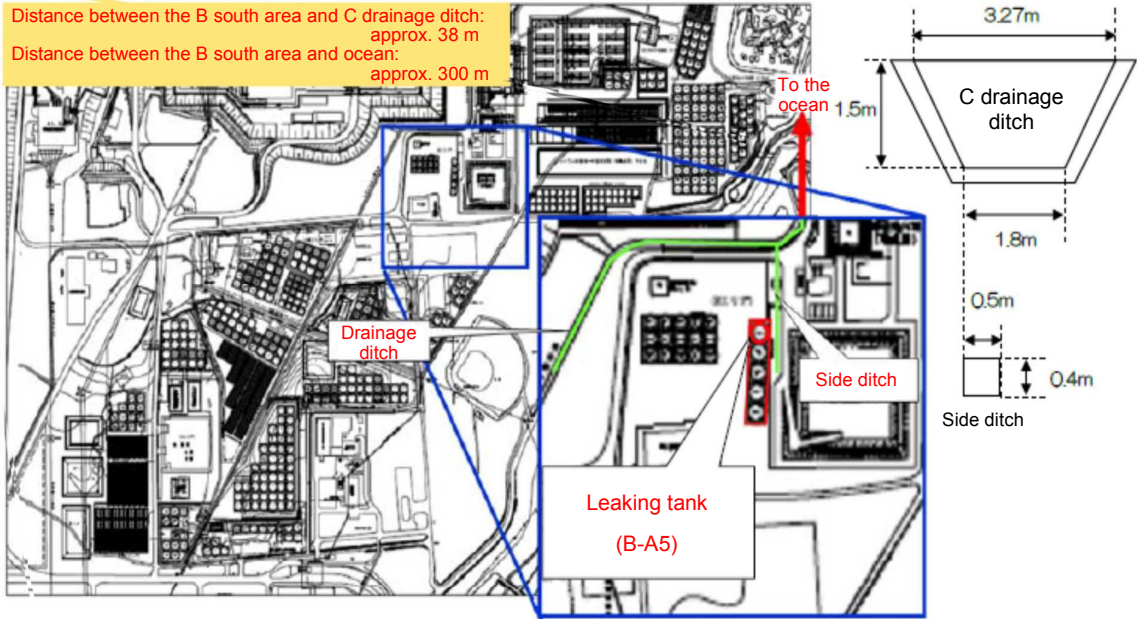
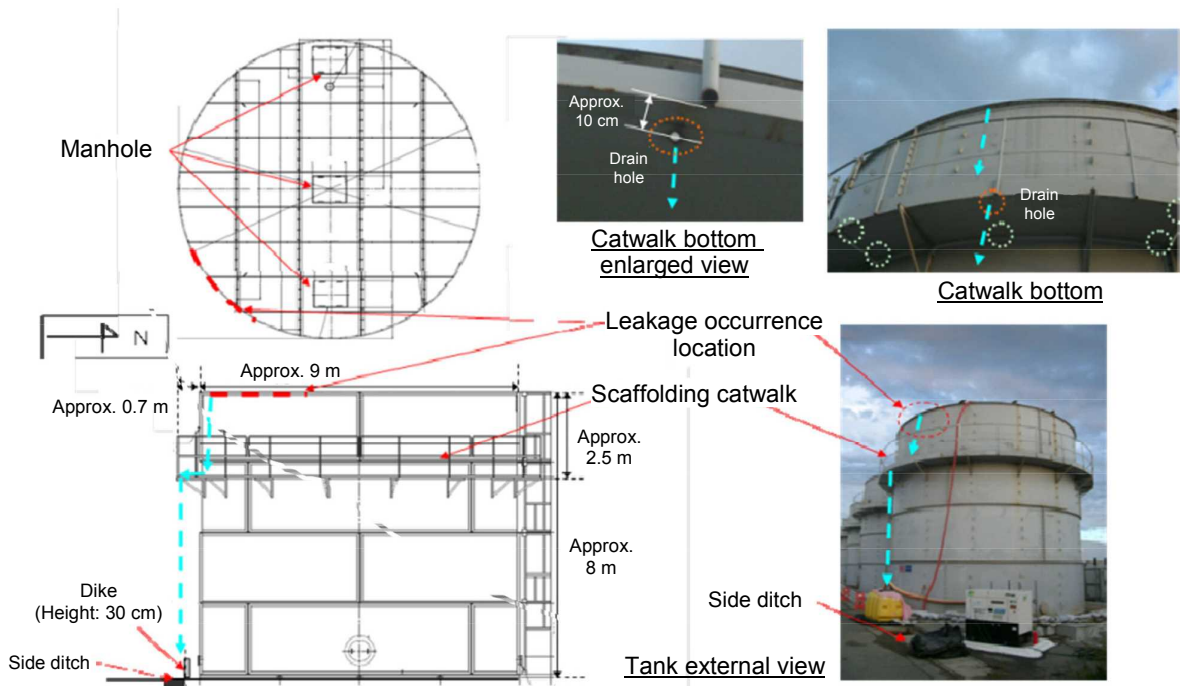
Figure 1 B south tank area and B-A5 tank leakage points (extracted from the TEPCO report)

Around 20:00 on 2 October 2013, a worker found that RO-treated water² stored in the B-A5¹ tank in the B south tank area was leaking from the tank ceiling plate, and that some of this water had leaked outside the dike³ (refer to Figure 1). On that day, there was a risk that rain water containing radioactive materials (hereinafter referred to as “accumulating water inside the dike”) would leak outside the dike due to the approaching typhoon. Therefore, water was being pumped up to the B-A5 tank, which is one of the five tanks connected by connection pipes (tanks B-A1 to B-A5), but leakage occurred from the B-A5 tank, which had become filled with water (refer to Figure 2).

B-A5 tank leakage points

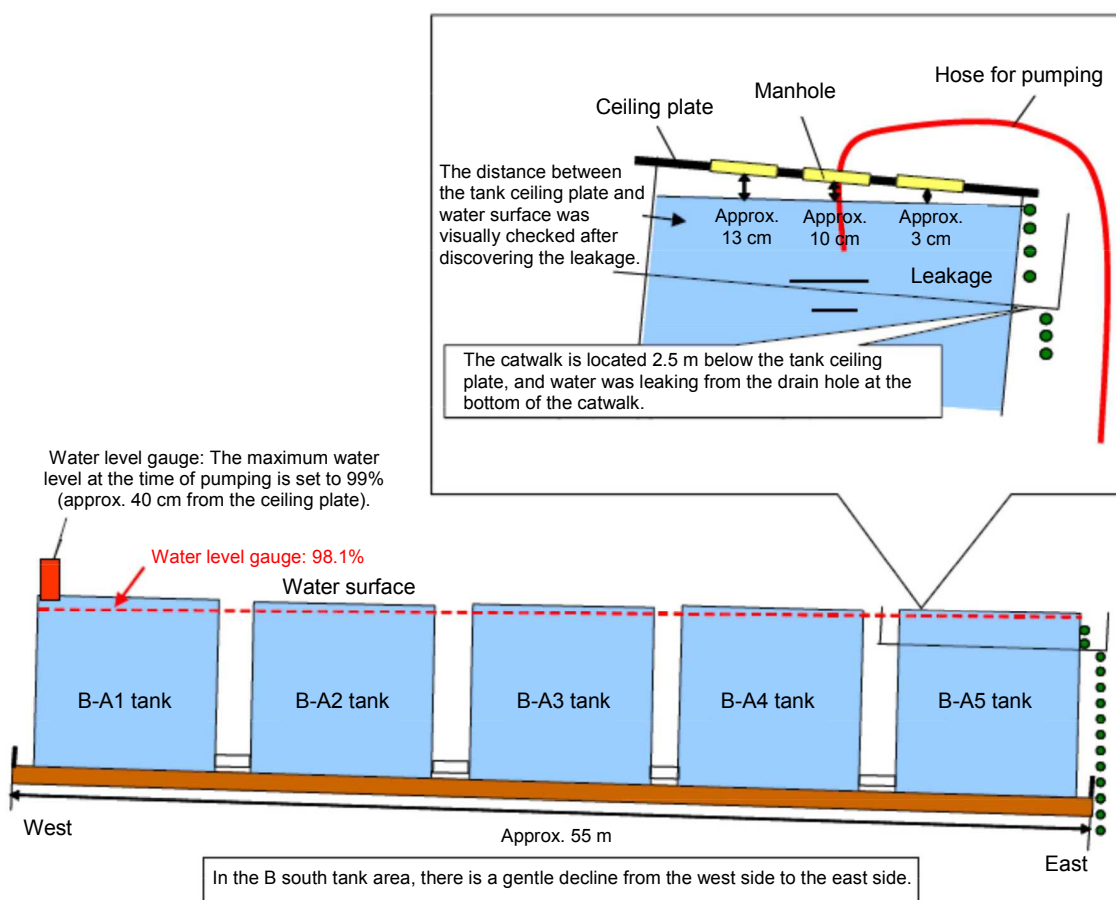
Figure 2 Tank installation situation in the B south tank area (extracted from the TEPCO report)

Though the water level of the tank was being monitored by the water level gauge attached to the B-A1 tank, the water level of the B-A1 tank, which was located at the highest position among the five tanks, was displayed as being the lowest.

The five tanks in the B south tank area (tanks B-A1 to B-A5) are arranged in series from west to east (starting with the B-A1 tank) and are connected by connection pipes. Due to the gentle decline from the site's west side to its east side, the B-A1 tank is positioned highest and has the lowest water level display. Although the tank water levels were monitored by the water level gauge attached to the B-A1 tank, neither the maximum tank water level nor a tank water level confirmation method considering inclination had been clarified.

- Tank water levels were monitored using the water level gauge of the tank at the west end (B-A1).
- The maximum water level for the water level gauge was set to 99% for the tank at the west end (B-A1) (approx. 40 cm from the ceiling plate) (water had been pumped up to the maximum water level because urgent pumping was necessary due to an approaching typhoon).

- Due to the inclination of the B south tank area site, the water level at the edge of the tank at the east end (B-A5) reached the tank ceiling plate when the water level exceeded 98.1% according to the water level gauge of the tank at the west end (B-A1).

- Although most of the water that leaked from the tank at the east end (B-A5) leaked within the B south tank area dike from the gaps in the tank side plates and catwalk, some of the water leaked outside the B south tank area dike from the drain hole at the bottom of the catwalk (scaffolding used for inspection) installed around the tank.

- Operational procedures, including a method for setting the maximum water level according to the tanks' installation situation, have been clarified.
- In principle, the water inside the dike is not pumped into tanks inside the same dike. However, when doing so is unavoidable, the actual water level is checked from the manholes at the tops of the tanks and remotely monitored by the operation management team in the water treatment facility control room in order to detect leakage at an early stage.
- If problems such as leakage are found, reporting, communication, and consultation are thoroughly performed and information is shared among concerned parties.

- In order to secure the transfer destination for accumulating water inside the dike, a new temporary tank group (notch tanks with a total capacity of 4,000 m³) was installed.
- Water level gauges were installed in all flange-type and welded tanks.
- The tank ceiling plates were caulked to improve their sealing properties, and the dike heights were increased to prevent accumulating water inside the dike from leaking outside the dike.

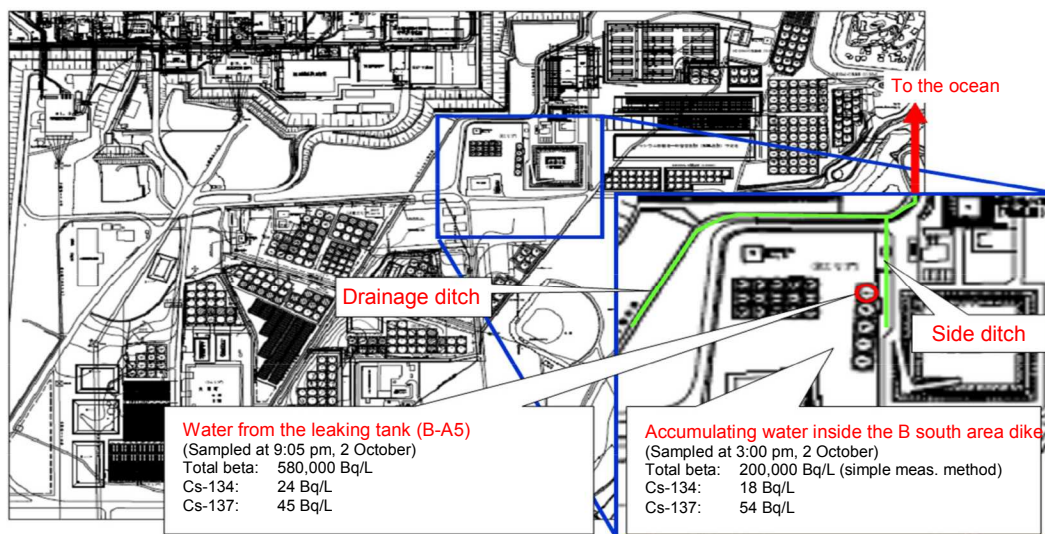
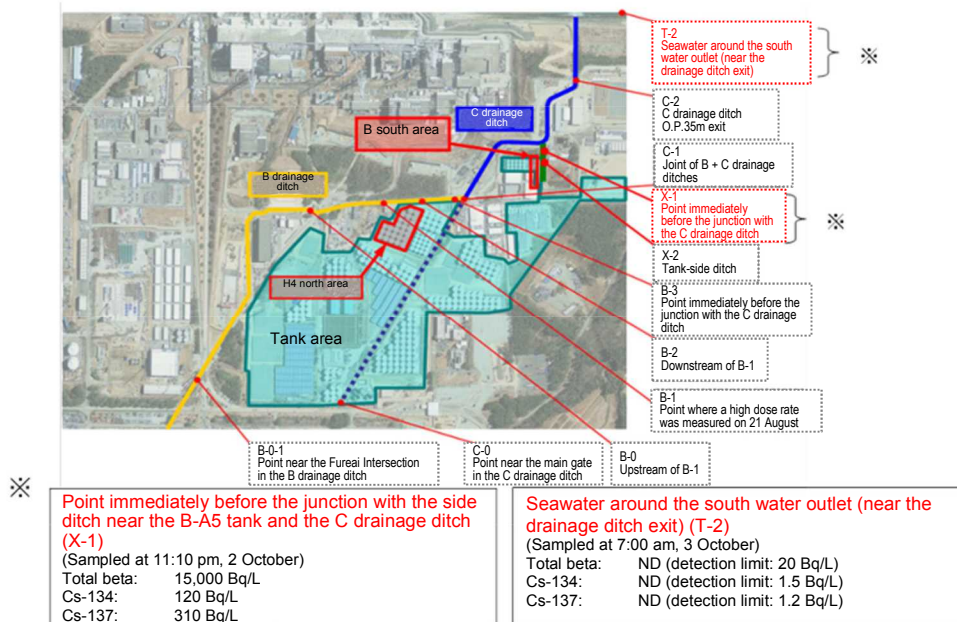
Figure 3 Results of analysis regarding leakage from the B-A5 tank (extracted from the TEPCO report)

The amount of leakage from the B-A5 tank was approximately 20 m³ based on an evaluation of the records of tank water level changes. From this amount, it is estimated approximately 0.43 m³ leaked outside the dike based on an evaluation of the status of leakage from a drain hole on the tank catwalk.

Results of analysis regarding leakage from the B-A5 tank

Results of analysis of water around the B-A5 tank

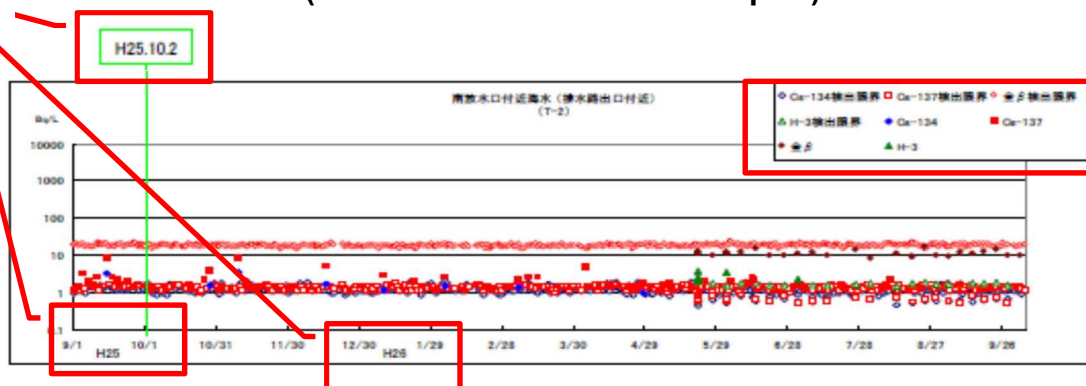
Figure 4 Results of seawater analysis regarding leakage from the B-A5 tank (extracted from the Secretariat of the NRA's document for a meeting with

On the morning of the day following the day leakage occurred, seawater near the south discharging outlet (near the C drainage ditch outlet) (T-2) was monitored. The results indicated Cs-134, Cs-137 and total beta were all less than the detection limits (detection limit: 1.5 Bq/L for Cs-134, 1.2 Bq/L for Cs-137, and 20 Bq/L for total beta) (Figure 3), showing no obvious increase when comparing the values before and after leakage occurred (Figure 4).

There is no obvious fluctuation in the results of monitoring before and after the leakage occurred into seawater near the south discharging outlet (T-2) of the C drainage ditch. Based on the facts above, the NRA evaluates that there has been no contamination of the ocean that raises any concern about influence to health and the environment.
