Evaluation of the report of Tokyo Electric Power Company regarding the leakage from the 4000-t square steel tank cluster at the Fukushima Daiichi Nuclear Power Station

28 April 2015

Nuclear Regulation Authority, Japan

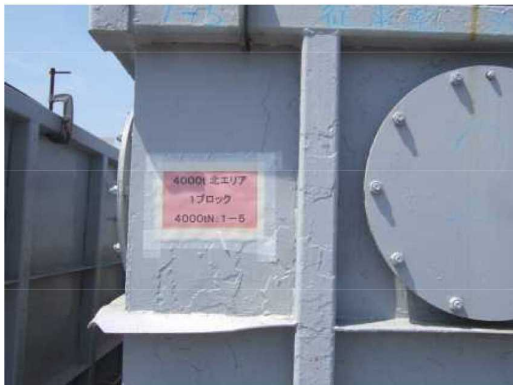
Photograph 1 Leaking notch tank

In the area concerned, water was observed to be dripping from portions around the bolts attached near the top panels of two tanks. The dripping rate was approximately one drop per second. We notified the electric utility of this event and ordered them to check the details.

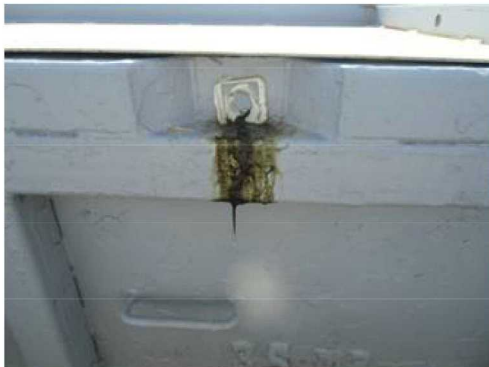
Leakage from tank No. 1-3

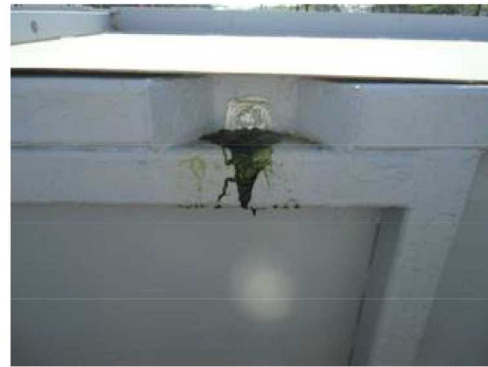
Leakage from tank No. 1-5

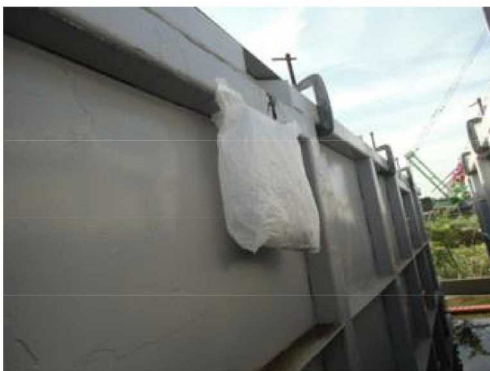
Vinyl bag attached to hold leaking water

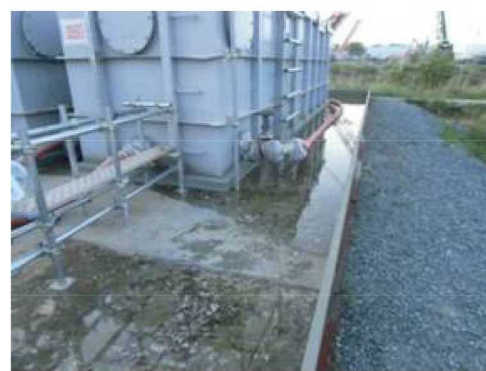
Rainwater accumulated in the dike

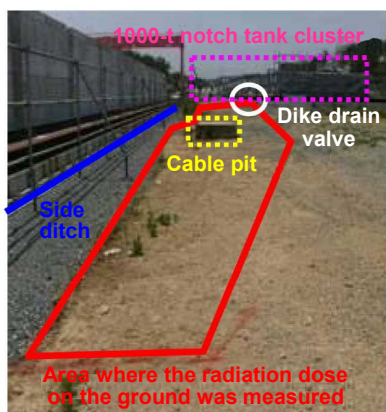
Despite the fact that the leaking water was dripping into a dike, the dike’s drain valve remained open. Tokyo Electric Power Company (hereinafter, referred to as “TEPCO”) measured the radiation dose (70 µm dose equivalent rate (β rays)) on the ground around the drain valve and outside the dike, finding a maximum radiation dose of 0.028 mSv/h within the area up to a distance of approximately 40 m from the drain valve. TEPCO therefore concluded that water in the tanks leaked outside the dike (refer to Figure 4).

Leakage to outside the dike

Area outside the dike

- b. Countermeasure to ensure the dike drain valves are closed
 - All drain valves of dikes in the notch tank cluster shall remain "closed." Rules regarding this operation shall be stipulated in company manuals.

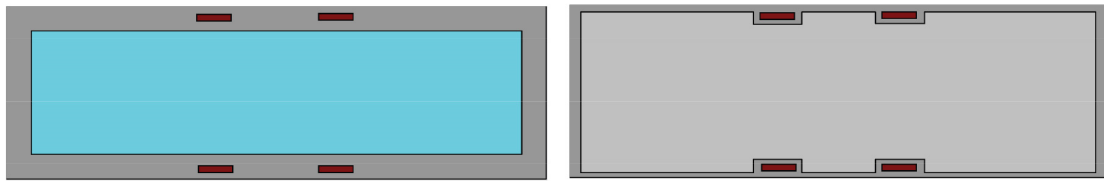
Tank installation stage

No gaps exist between the notches of the tank top panel and the hanging metal at the upper end of the tank side panels during the tank installation stage.

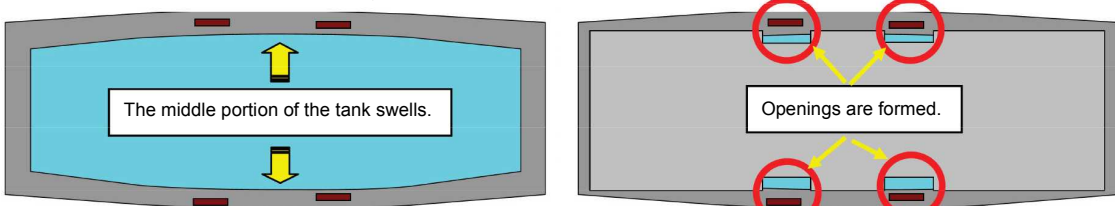
After storage of rainwater accumulated in the dike

While storing water, the tanks swelled in the middle of the upper-end part of their side panels. This swelling caused gaps (openings) to develop between the tanks' top panels and hanging metal attached to the upper end of the tanks' top panels (refer to Figure 5).

Rainwater entered the tanks through these openings that had formed at the tanks' top panels, gradually leading to an increase in the water level of the 1000 t notch tank cluster. As a result, stored water leaked into the dike from the portions around the bolts, which had low cut-off performance.

The notch tank stores rainwater accumulated in the dike, and its middle portion thus swells outward. As a result, gaps (openings) are formed between the notches of the tank top panel and the hanging metal at the upper end of the tank side panels.

- Covers shall be installed over the notch tank cluster to prevent rainwater from entering the openings along tanks' top panels and to prevent rainwater accumulation from increasing in the dike for the notch tank cluster.

- Inspections shall be carried out on the notch tank cluster once a week to confirm that tanks' water levels do not exceed the reference upper limit (approximately 20 cm below the tanks' top panels).

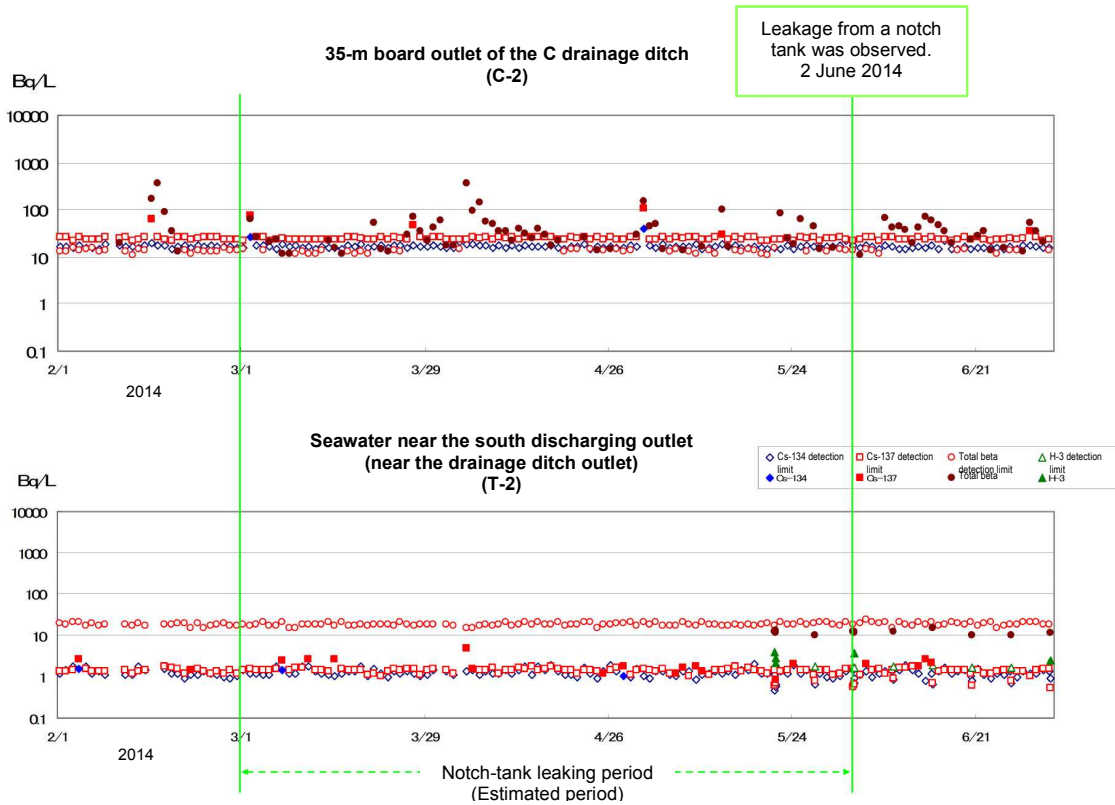
Figure 6 Results of drainage-ditch and ocean monitoring (extracted from the Secretariat of the NRA's document for a meeting with TEPCO)

There is no obvious fluctuation in the results of monitoring before and after the leakage occurred in the vicinity of the 35 m board outlet (C-2) of the C drainage ditch and the vicinity of the south discharging outlet (T-2). The NRA therefore concludes that this event did not cause ocean contamination that raises any concerns about effects on health or the environment (refer to Figure 6).
