Ceaseless Quest for Safety Improvement after TEPCO Fukushima Daiichi Accidents

Nuclear Regulation Authority Japan
Masaya YASUI

The second-phase of accident investigation/analysis of Fukushima Daiichi started from September 2019.

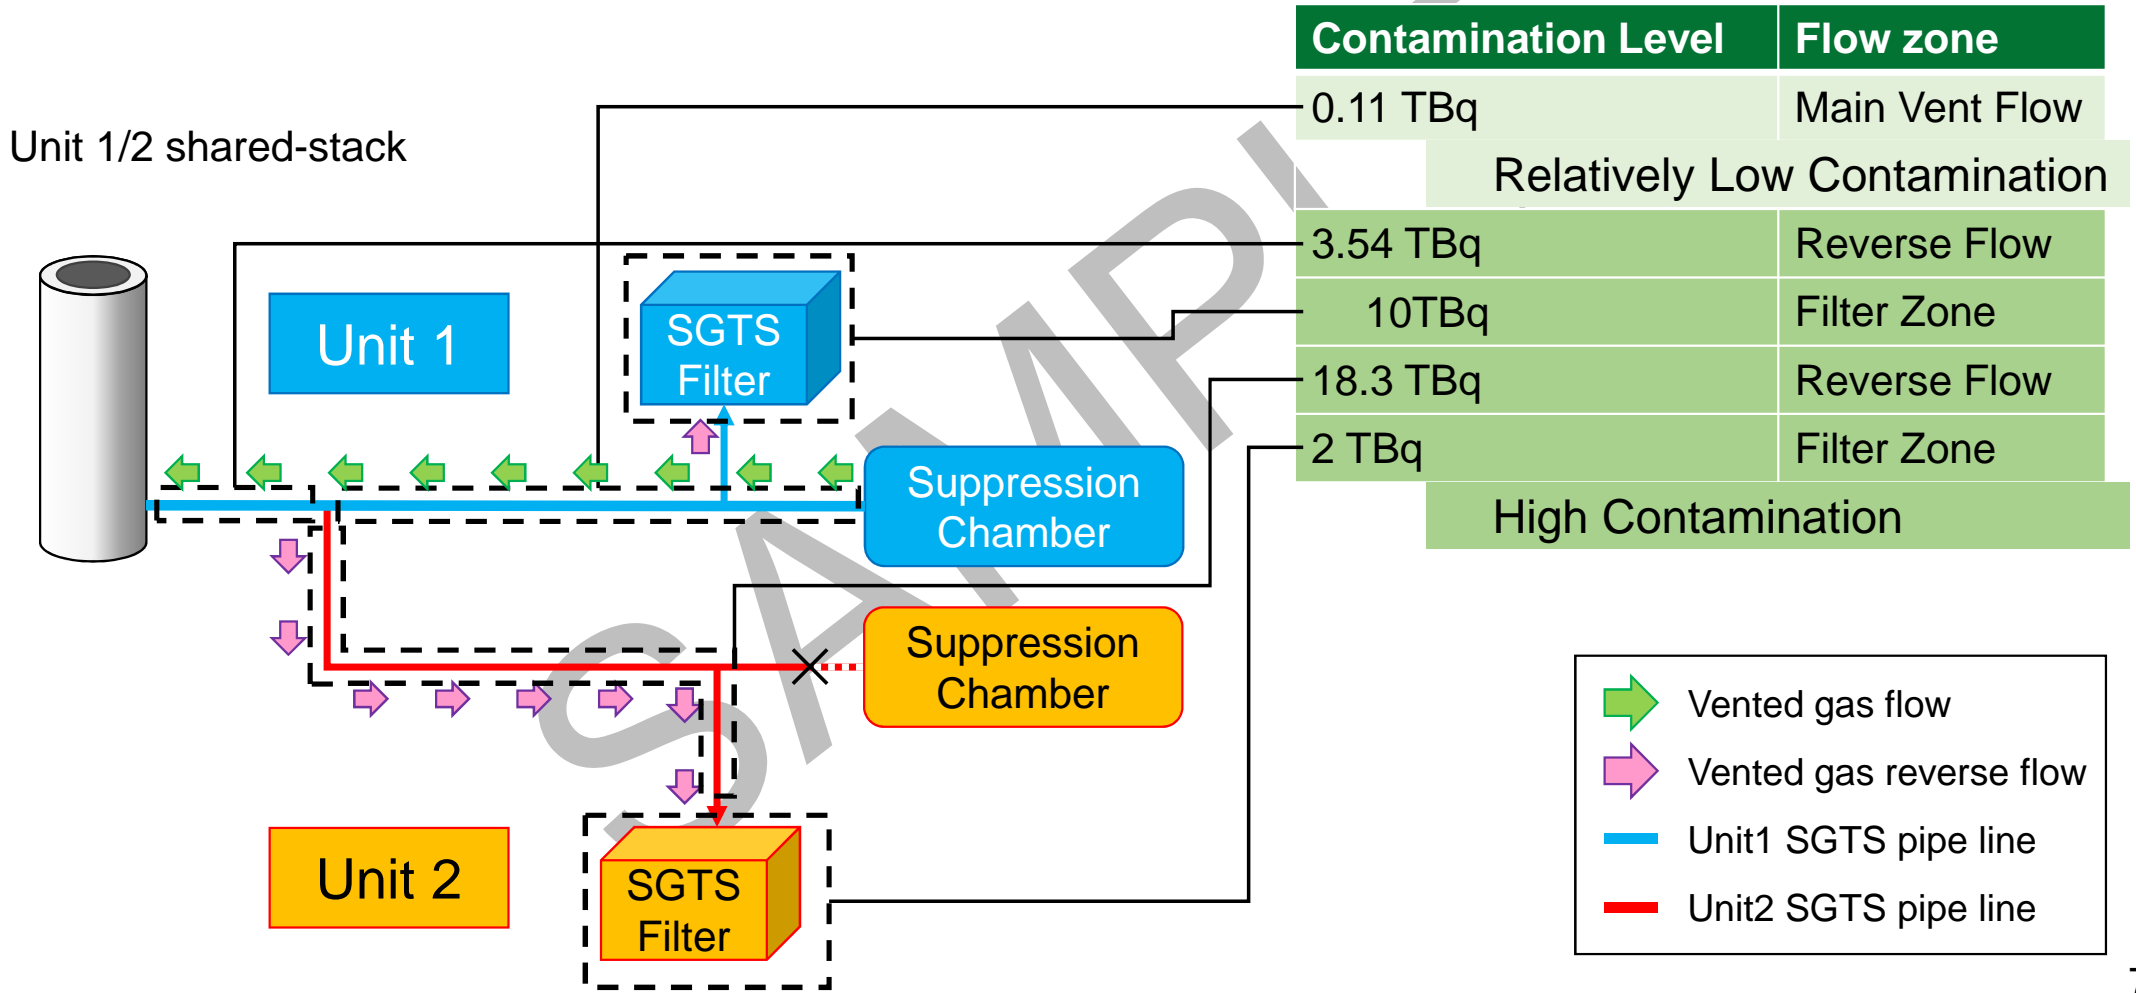
Fig 4-1. Contamination Level of Vent Lines

- Specific contamination pattern in hardened vent lines of unit 1/2.
- Very high contamination at the bottom of the stack in unit 1/2.
- High concentration of Cs¹³⁷ under the Shield Plugs.

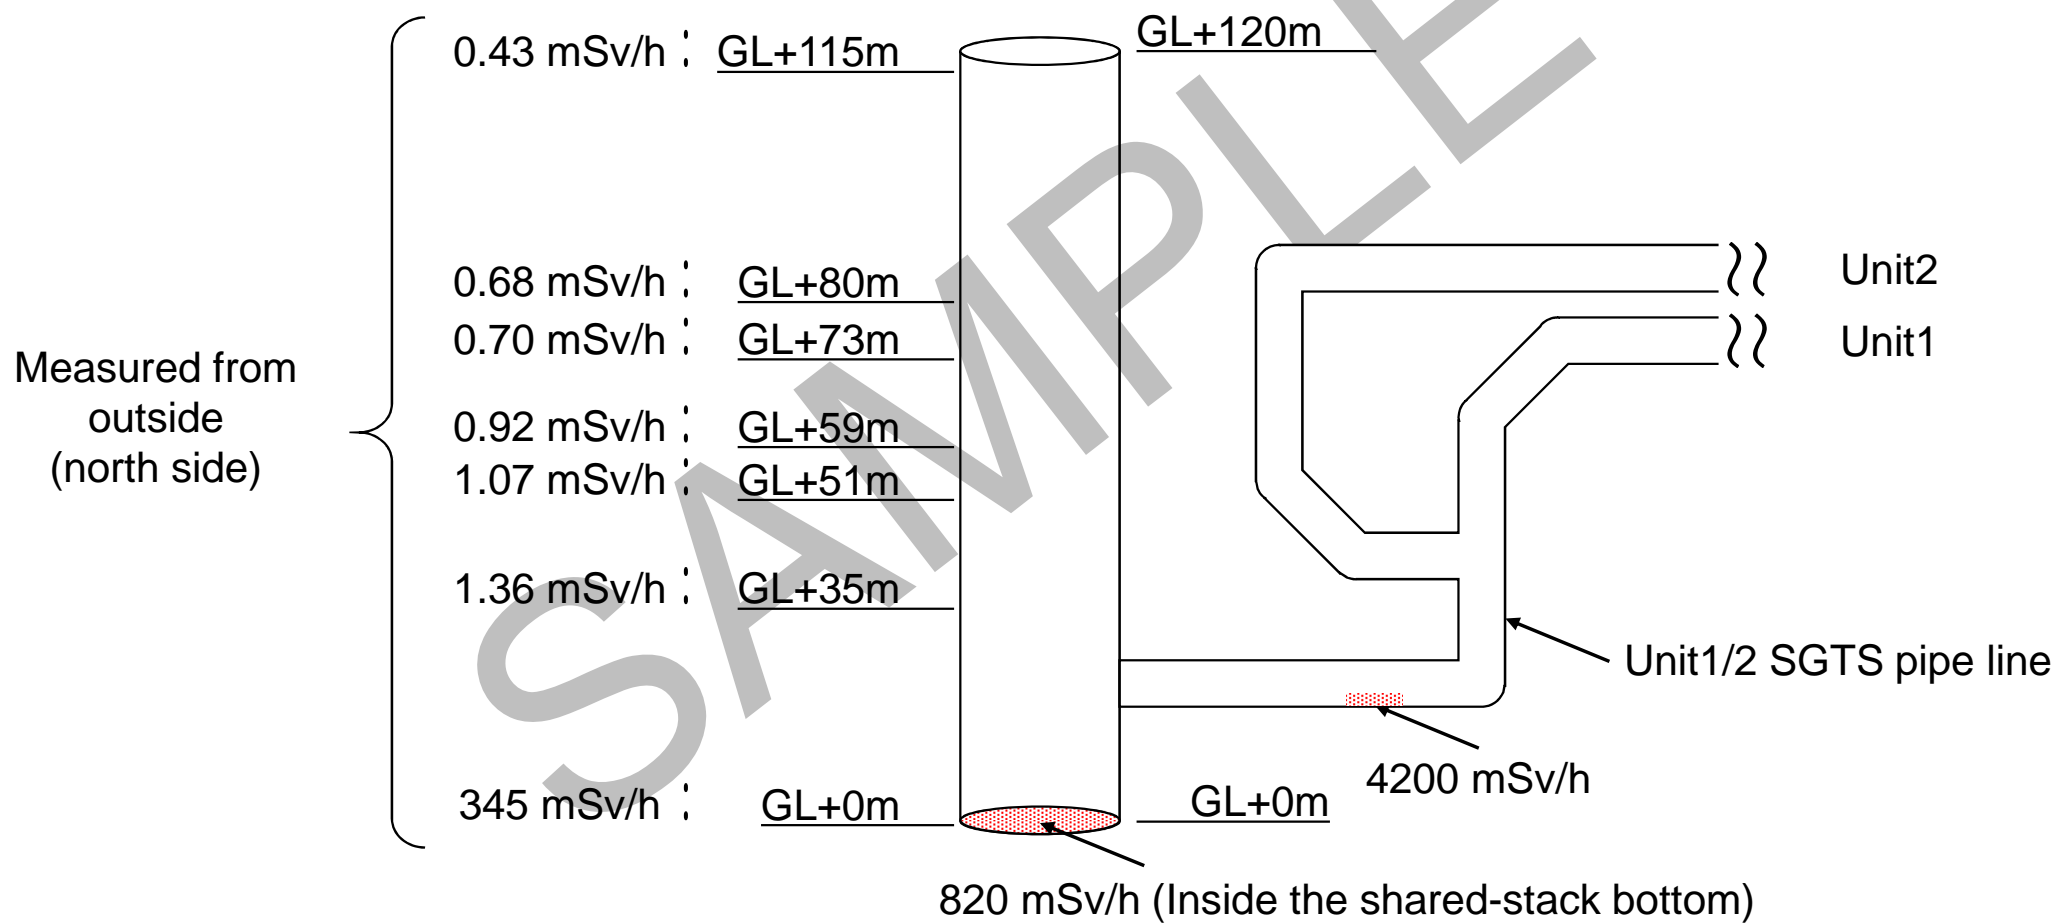
Fig 4-2. Unit 1/2 Shared-Stack

- The knowledge may lead to
 - explanation of the relatively small amount of Cs¹³⁷ release to the environment (around 15-20 PBq).
 - explication of the cause(s) of high radiation field (~10Sv/h in 2011 August) observed near the Unit1/2 shared stack bottom.
 - efficient approach to suppress the Cs¹³⁷ release to the environment
- NRAJ plans to Re-evaluate the benefit of the hardened vent system. (BWRs in Japan still have hardened vent system. Filtered-Venting System is installed) (P)

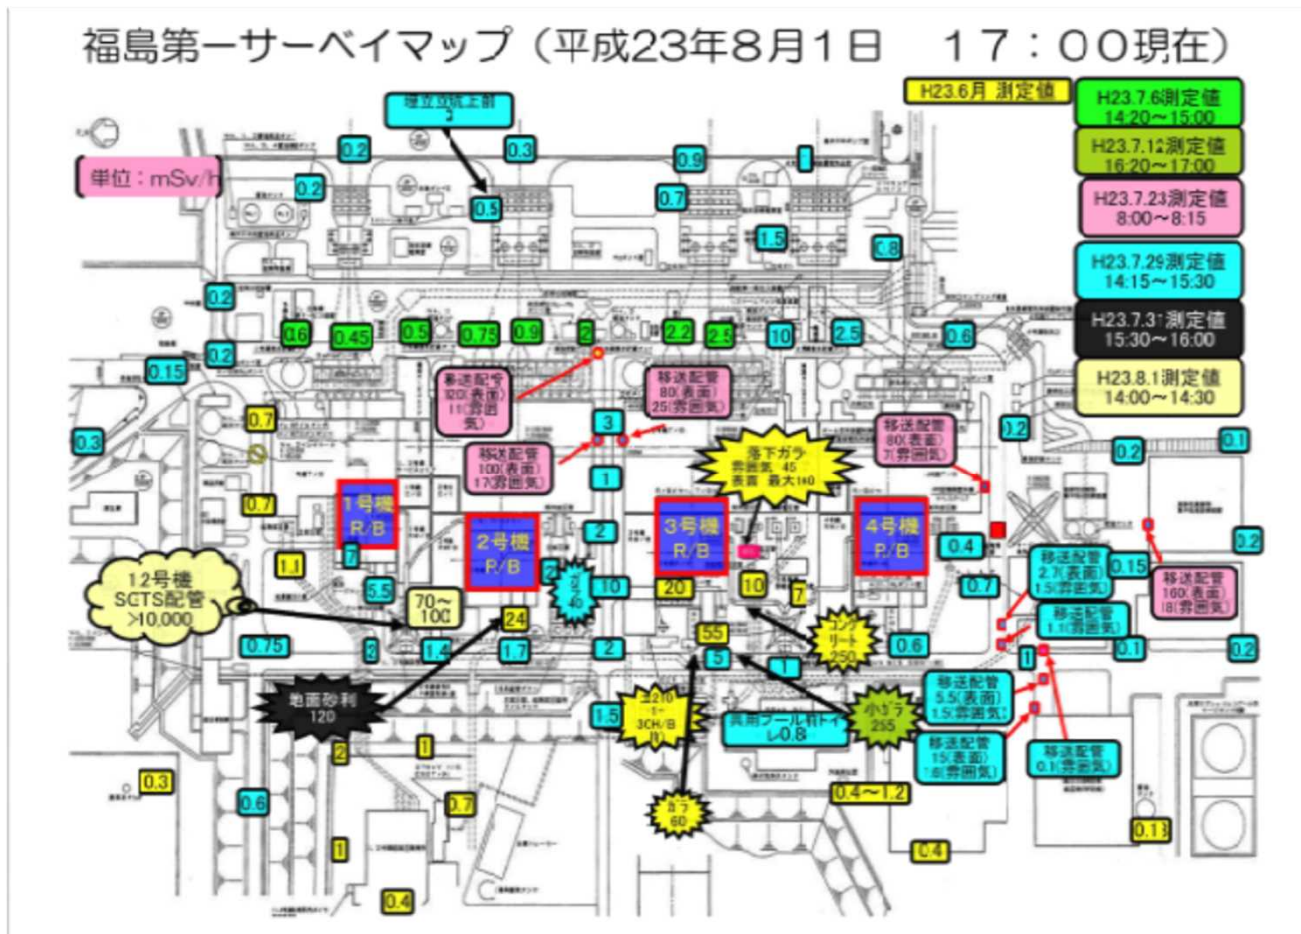
Survey Map (2011.8.1)

The high radiation level was one of the major obstacle soon after the accidents.

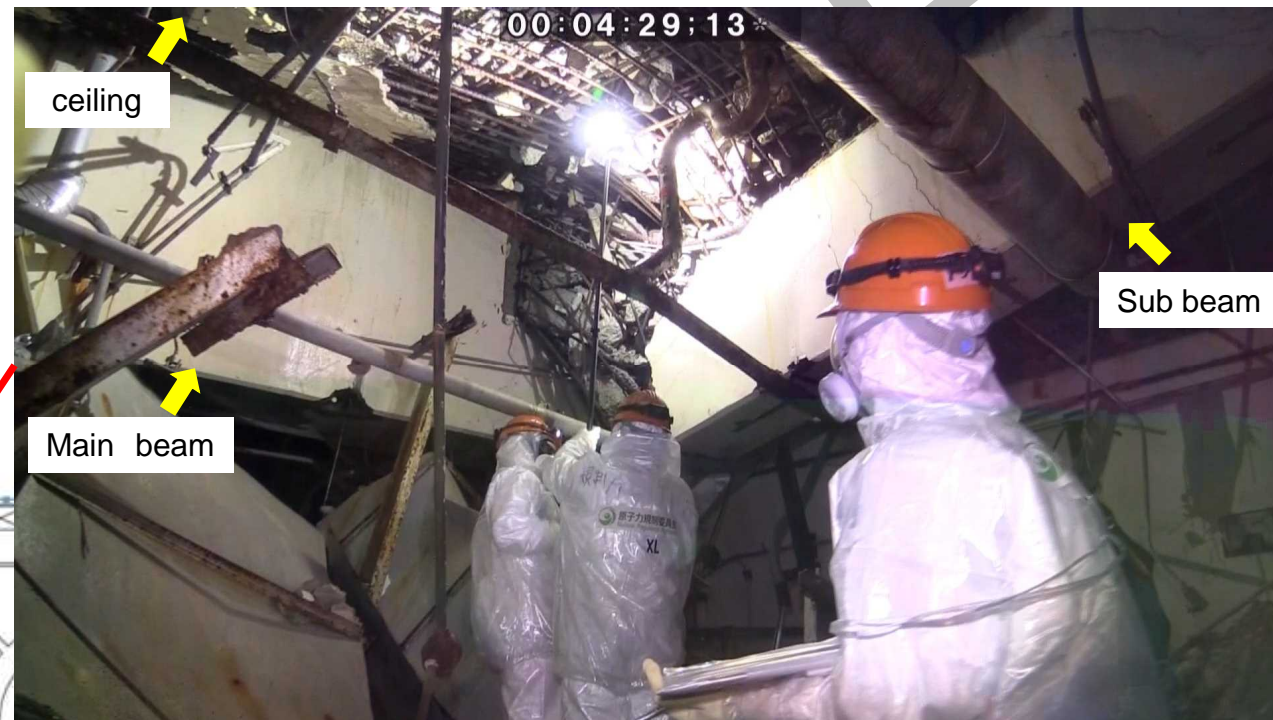
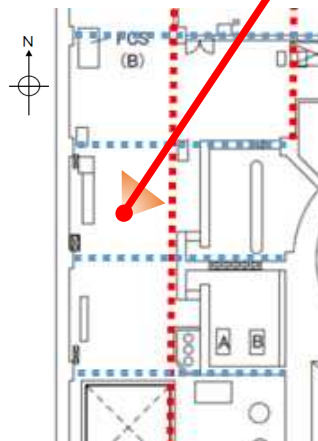
Unit3 R/B 3rd floor

NRAJ observed that some beams of the 3rd floor ceiling broke.
NRAJ considers this indicates that some explosions occurred in the 4th floor.

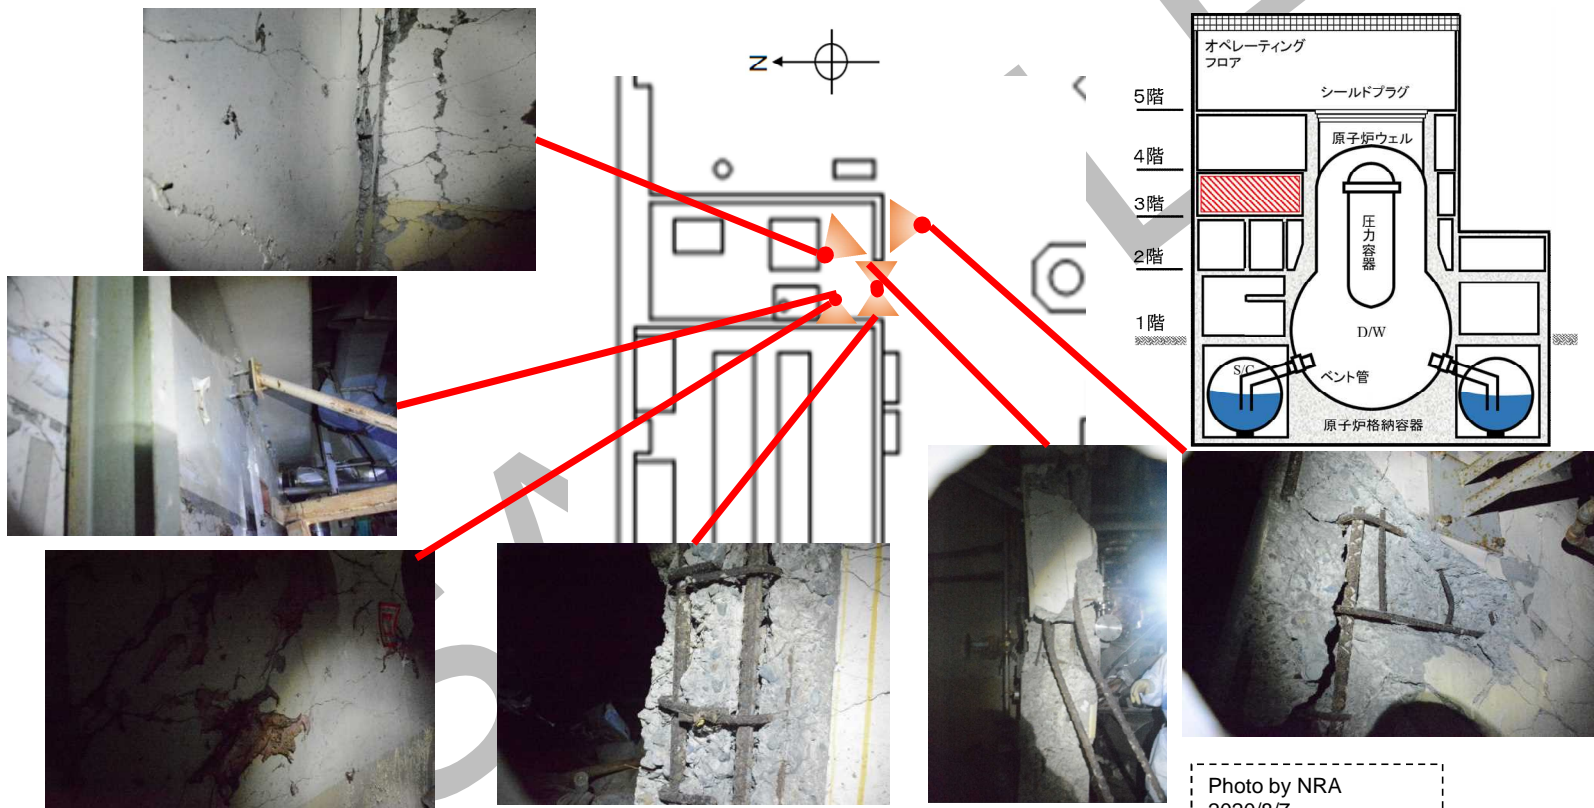
Unit 4 R/B 3rd floor (North side) CRD repair room

- At Unit1 and Unit3, venting activities were taken after hydrogen leaked from PCV to reactor buildings.
- 3rd floor of Unit3 was severely damaged. (NRA 2021)
- Close investigation of Unit4 indicated that hydrogen explosion occurred not only on the operation floor (5th floor), but also in CRD exchange room on 3rd floor. (NRA 2021)
- Unit4's reactor building was damaged by hydrogen explosion around 40 hours after the final hydrogen supply from the Unit3. (NRA 2021)
- Investigation inside the Unit2 reactor building shows that the path(s) from reactor well to SGTS ducts existed. (TEPCO xxxx)
