TOPIC 3 - CORE DEBRIS LOCATION EVALUATIONS

MITCH FARMER

Nuclear Science & Engineering Division
Argonne National Laboratory

Fukushima Forensics Meeting, November 17-18, 2022

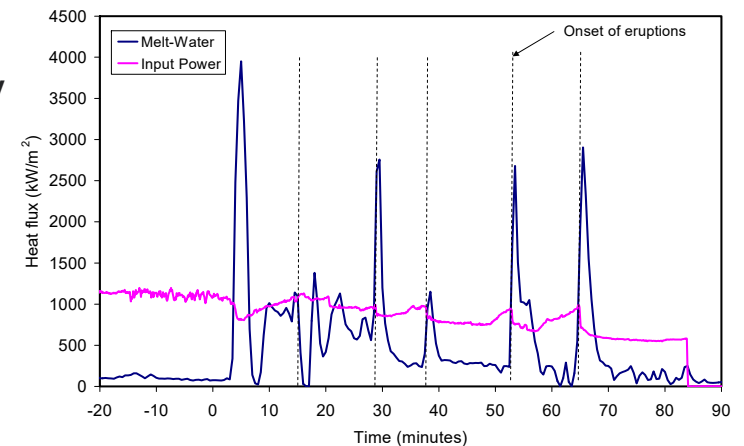
MACE SCOPING TEST²

LCS concrete, 30 cm x 30 cm square test section, 130 kg corium mass, high power density test

- Top crust anchored to sidewalls, and was mechanically stable for rest of test.
- Due to high power density (700-1400 W/kg fuel), relatively thin conduction-limited crust formed.
- Periods of high melt void fraction occurred in which the melt re-contacted the crust, leading to melt eruptions and particle bed formation.
- Anchored crust viewed as ‘non-prototypic’ and the test section design was changed to refractory sidewalls and larger scales in subsequent tests in an effort to achieve a floating crust boundary condition.

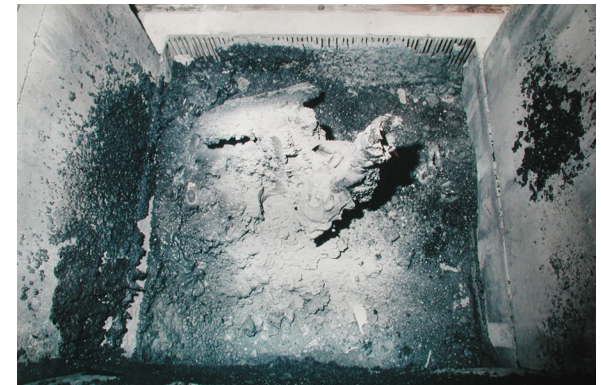
After removal of erupted material

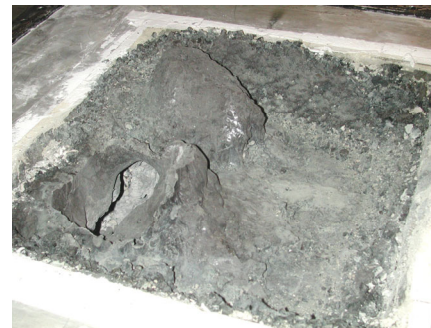
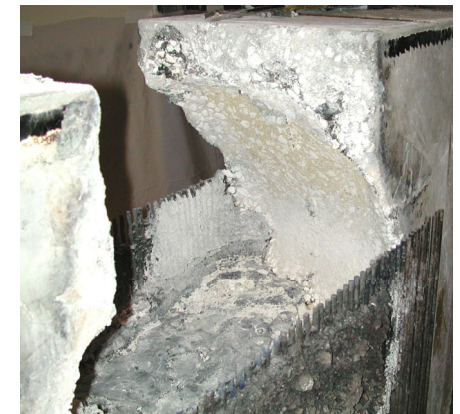
OECD/MCCI TEST CCI-2²

LCS concrete, 2-D test section with 50 x 50 cm initial cavity size; 6 hours of dry cavity ablation, followed by cavity flooding

- No apparent crust anchoring, but large accumulation of core debris in upper portion of test section due to deposition from highly swelled melt pool height.
- Extensive ablation above the solidified debris over the basemat; likely due to radiation heat transfer from upper surface of melt during the test.
- Relatively thick (3 cm layer) of calcined concrete found on top of debris, supporting the idea that this material was produced by radiation heat transfer and not ablation via contact with melt.

3. The dry cavity tests also showed evidence of ablation above the collapsed melt height, leaving calcined powder buildup on top of the crust material. The vertical extent of this ablation was limited by bridge crust material attached to structure above the melt. The bridge crust apparently acted as an insulator preventing ablation above the crust.

- *Could partially explain the occurrence of white powder layers covering material in various locations in 1F1.*
 - *The fact that the powder was not incorporated into the melt, but rather accumulated on top of the upper crust, indicates that this material was probably formed by radiation heat transfer from the melt as opposed to direct contact with the core debris.*

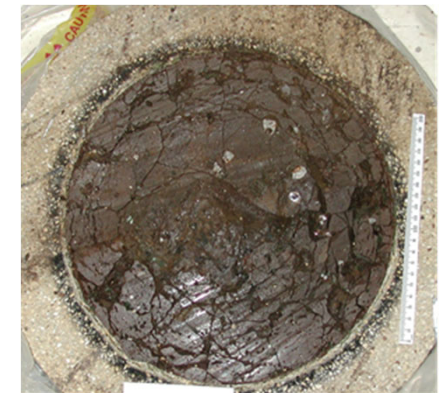
- Occurrence of anchoring in MACE tests raised concerns that if this happened at plant scale, it may prevent debris cooling by forming an insulating gap between the crust and remaining melt.
- On this basis, load tests were conducted on sectioned corium ingots from SSWICS tests to measure tensile strength of core debris containing inherent crust cracking and porosity.
- Results indicated that crusts are weak, and that sustained anchoring at plant scale is unlikely given the 6 m cavity span in many plants.
- Rather, periodic crust anchoring and 'breach' would likely occur, leading to renewed pathway(s) for water to re-contact and ingress into the debris.

Max centerline stress before fracture for ingot sections under point load at room temp

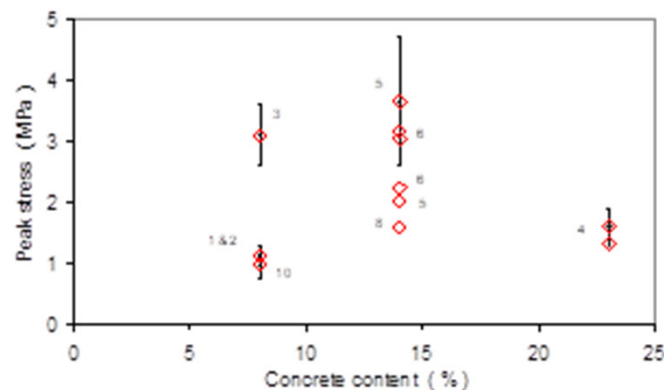
Measured section strength and calculated peak stress in a 6 m OD self supported crust

- MELCOR melt composition and initial temperature the same as in Ref. 7.
- Concrete type assumed to be CORCON Basalt.
- Based on crust strength measurements made as part of OECD/MCCI program, a tensile strength of 3 MPa is assumed (see pg. 12).

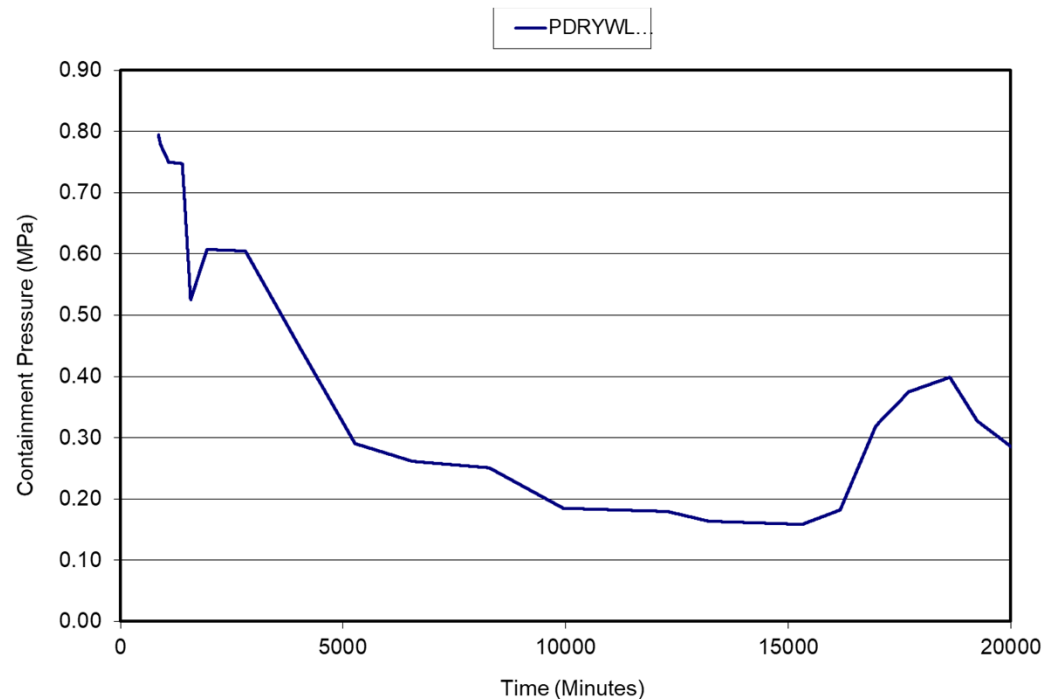
ASSUMED CONTAINMENT PRESSURE

Important as this impacts superficial gas velocity from concrete decomposition and melt void fraction

- Estimated by using TEPCO data where it exists and interpolating using MELCOR results⁸ in regions where data does not exist....

Interpolated Data

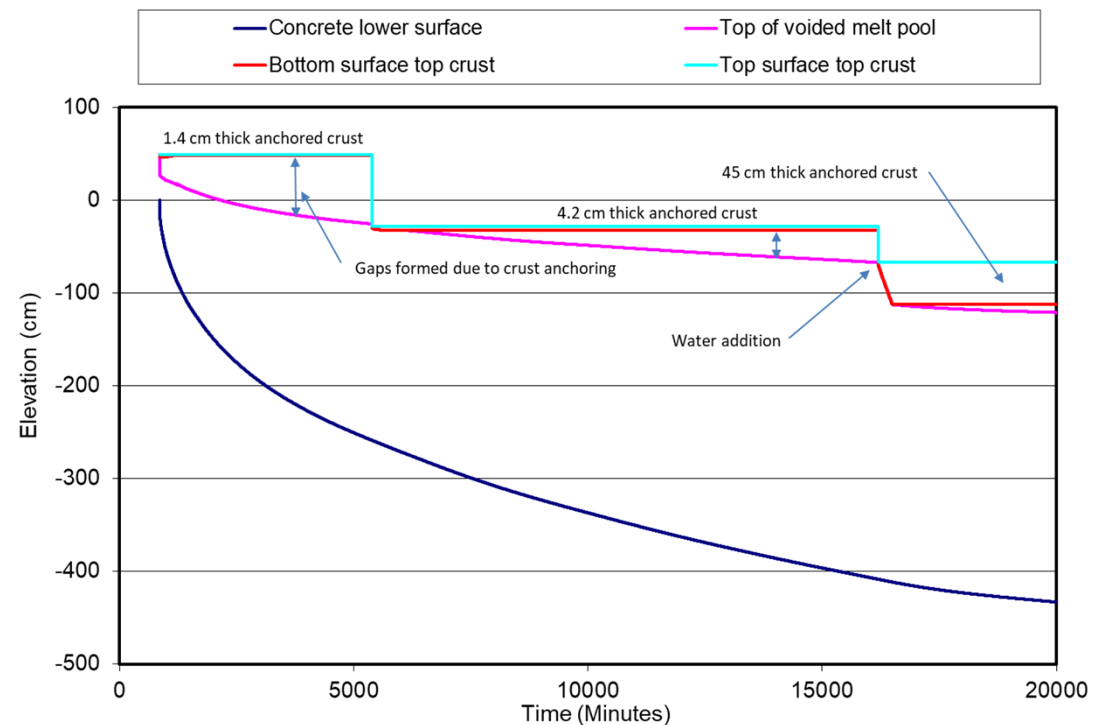
Surface elevation of crust and voided melt height

- Results indicate possibility of three crust anchoring and two crust failure events in the region spanning the pedestal doorway over the calculated time interval.
- Crusts are anchored over a major fraction of the time.
- Water addition caused 2nd failure.
- Although not explicitly modeled, failure events would leave crust ledges on concrete walls (1st 1.4 cm thick, the 2nd 4.2 cm thick).
- Large time intervals during dry phase in which gaps formed would allow lateral ablation by radiation heat transfer to exposed concrete.

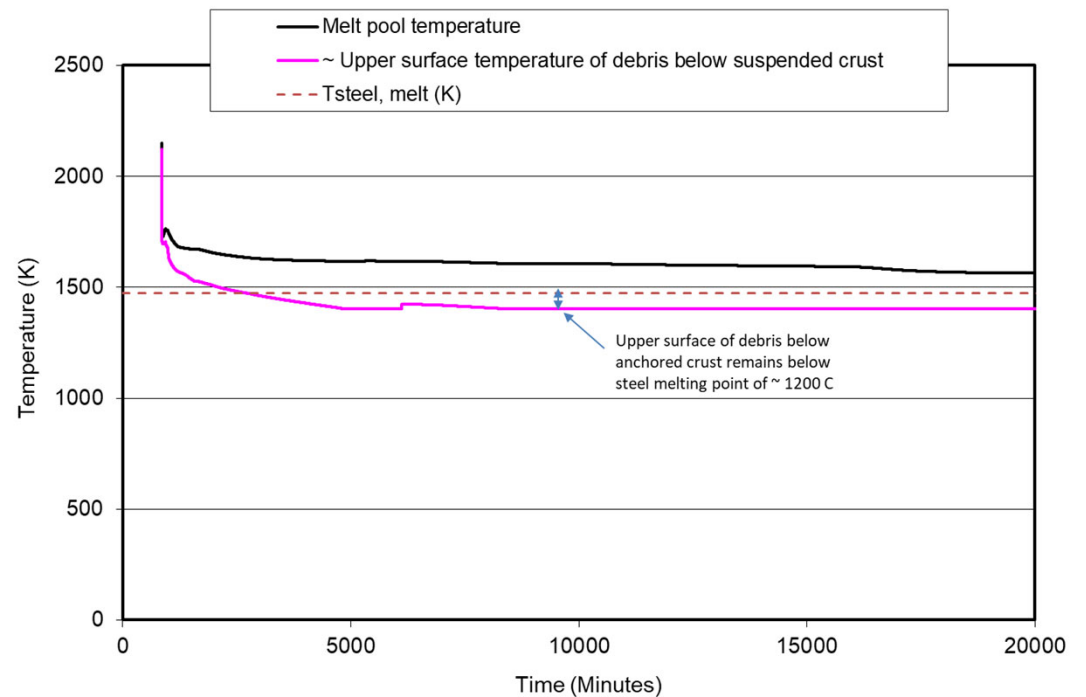
Melt and crust temperature results

- During extended periods of crust anchoring before flooding, the upper surface temperature of the debris below the bridge crust remains below steel melting temperature (assumed to be 1200 C = 1473 K here).
- Thus, the rebar exposed by radiation-driven concrete ablation in the doorway sidewalls would not have been ablated according to this modeling result.

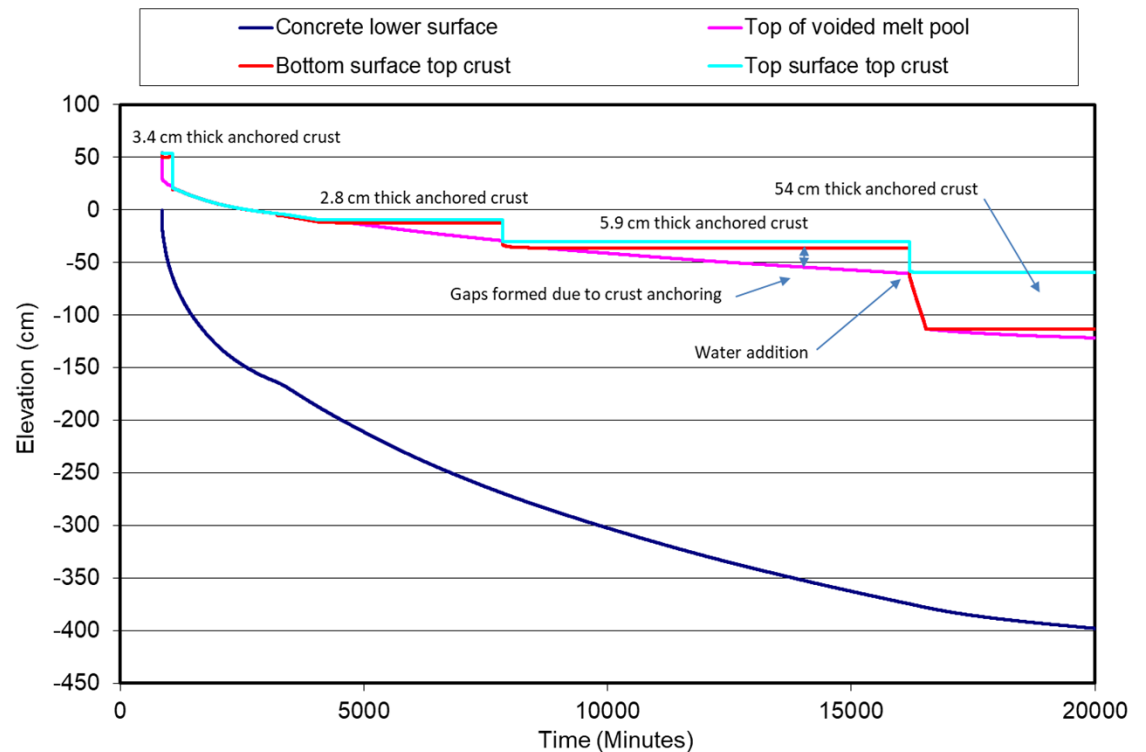
Surface elevation of crust and voided melt height

- Overall, trends and observations are similar to doorway results. However, a few differences:
- Four anchoring events as opposed to three for the doorway case.
- Early on, there was an extended period (~ 2 days) in which the upper surface was initially crust free, and then was covered with a crust that floated.

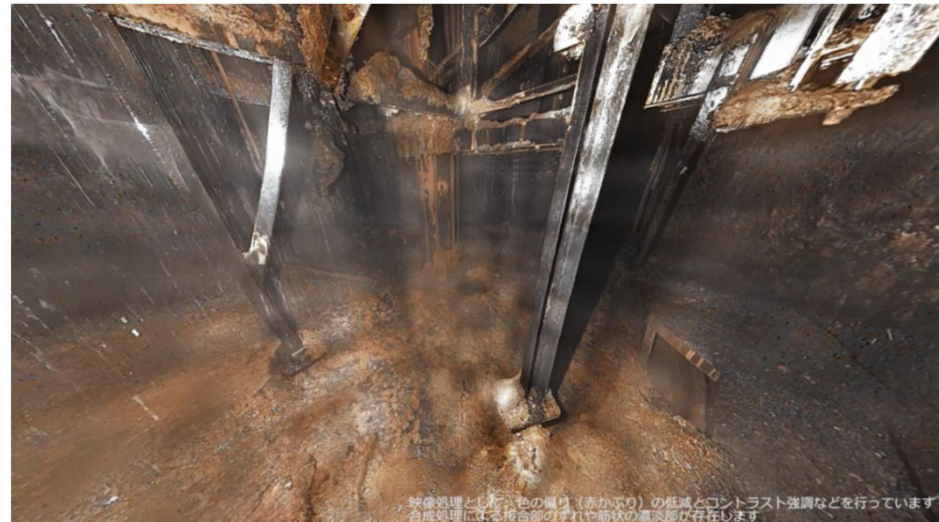
1F2 in-pedestal debris distribution

- 1F2 examinations have revealed extraordinary information on ex-vessel core debris distribution within the pedestal, including data on water injection characteristics.

- Specifically, video indicates that injected water penetrates the core debris (50-70 cm in depth) and passes through that material during passage to drywell annulus where water level is constant at ~30 cm. This is clear evidence of water ingress.

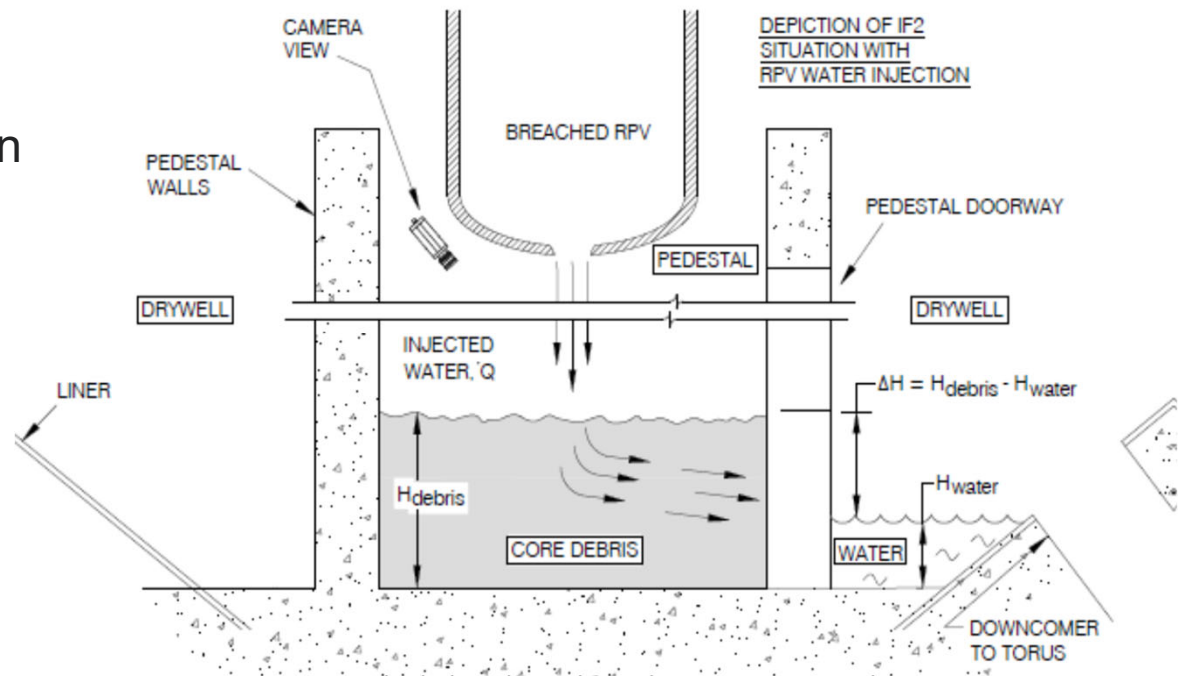
- Water injection flowrate would be gradually increased until it pools above the debris and begins to flow out the doorway, this would be flooding limit, \dot{Q}_{limit} .
 - Camera footage would be needed to determine when this point is reached.

- With flooding limit known, debris permeability can be estimated using the equation (based on Darcy's law):
