Evaluation of the report of the Tokyo Electric Power Company regarding the leakage from the double strainer differential manometer for the water transfer pipes of the desalination system at Fukushima Daiichi Nuclear Power Station

15 April 2015
Nuclear Regulation Authority, Japan

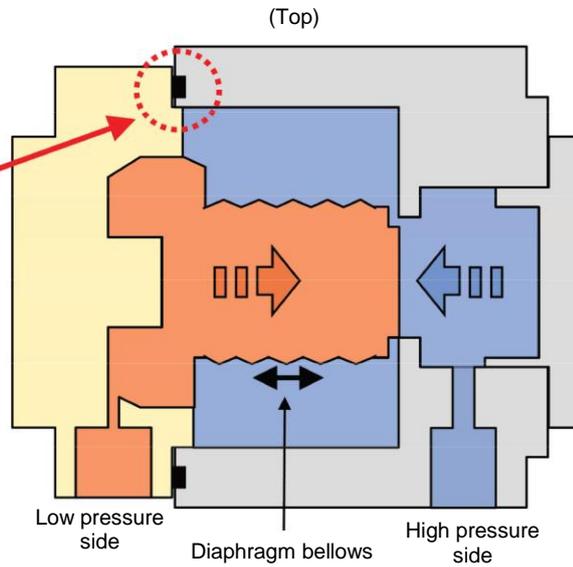
Overview of the affected differential manometer

The portion shaded orange (low pressure side) and the portion shaded blue (high pressure side) are filled with water, and the diaphragm bellows expands or contracts due to each portion's water pressure, causing the differential manometer to output a value.
