Evaluation of the report by Tokyo Electric Power Company regarding the leakage from a connection valve between A5 tank and A6 tank in the G4 South Tank Area at the Fukushima Daiichi Nuclear Power Station

Nuclear Regulation Authority, Japan
17 June 2015

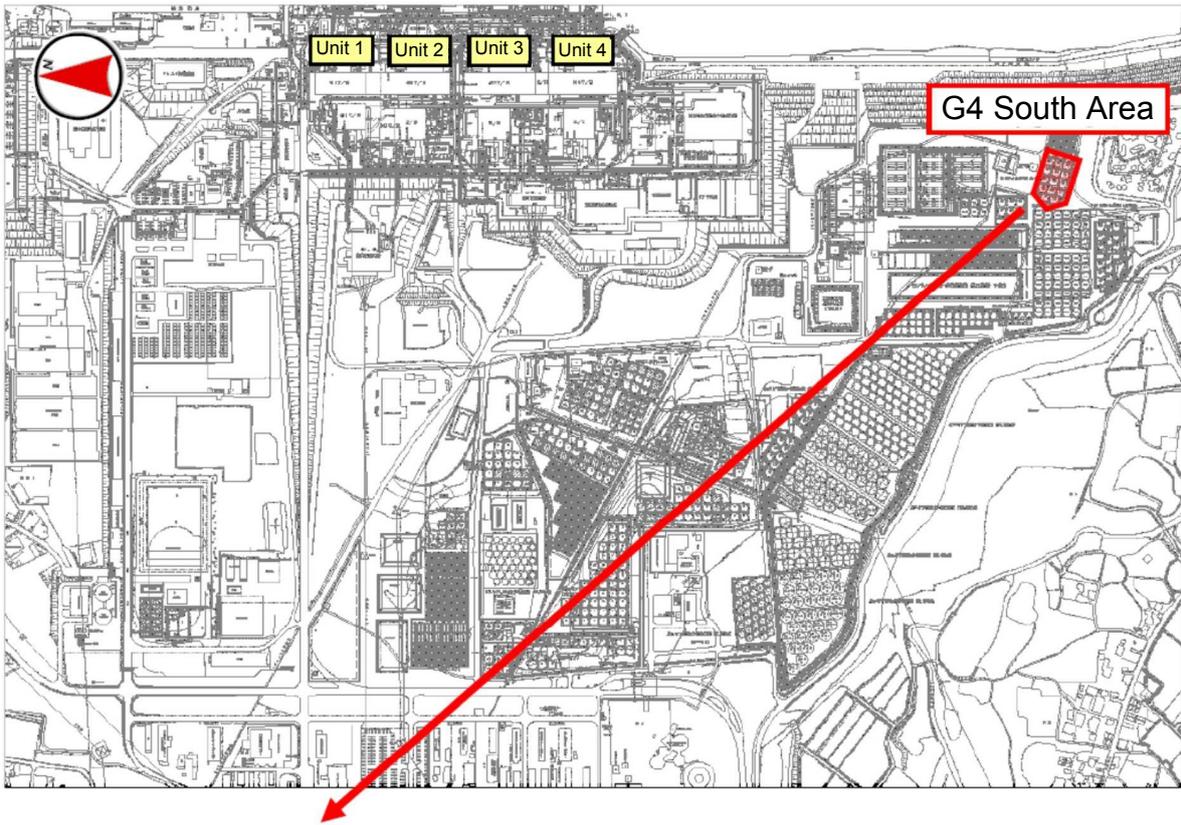
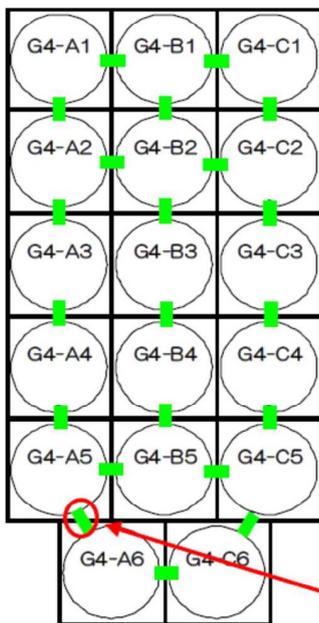
Figure 1 Location of the connection valve that caused the leakage (extracted from the TEPCO report)

Location of the Valve

Location of the leakage
