Evaluation of the report by Tokyo Electric Power Company regarding an alarm set off from a side ditch effluent radiation monitor at the Fukushima Daiichi Nuclear Power Station

Nuclear Regulation Authority
September 2, 2015

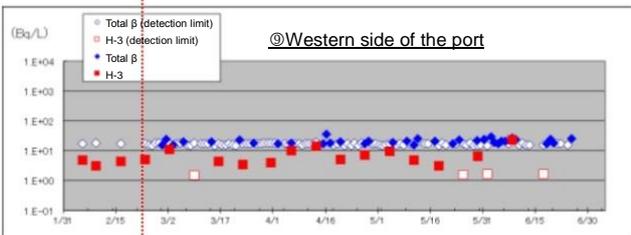
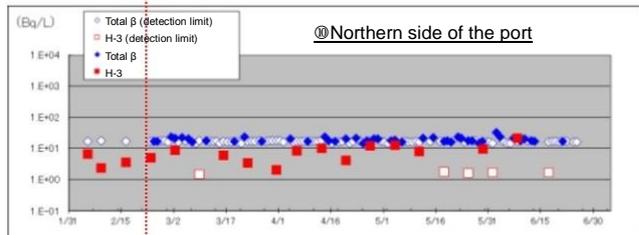
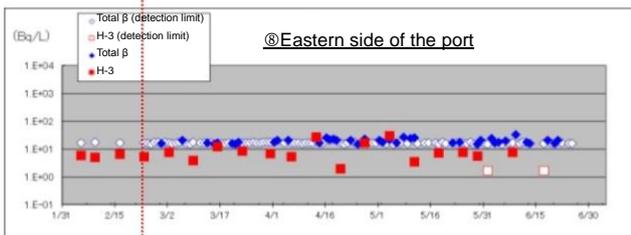
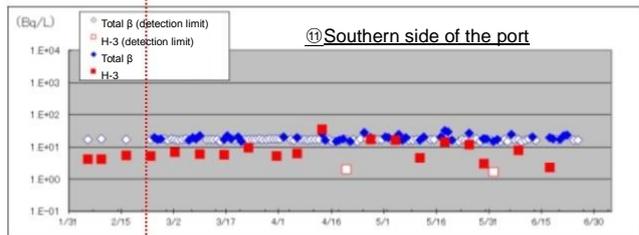
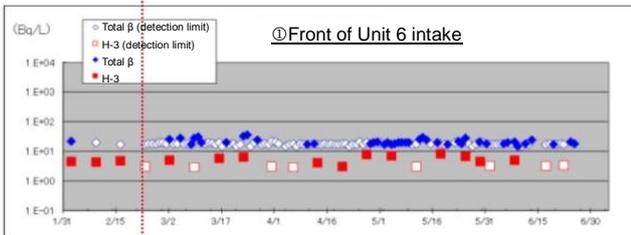
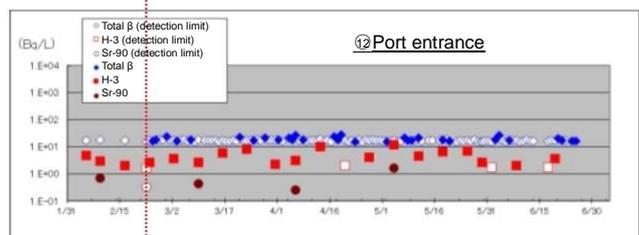
The radiation level of total β nuclides that outflowed between around 9:30 on February 22, 2015, when an increase in the reading of the monitor was observed, and 11:35, when BC-1 gate was closed, was estimated at about 4×10^8 Bq (see Table 1) on the basis of the readings of the monitor and the data indicating the flow rates in drainage channels. From February 23, the frequency of measuring radioactive concentrations in seawater at 12 locations inside the NPS port was modified from once a week to once every day to monitor radiation expansion, but no significant variation was found as a result of analyses performed by late June (see Figure 4).

Because the results of monitoring the inside of the intake channels for Unit 1 to 4 and port showed that the radioactive concentrations of the total β nuclides inside them were within normal variation range and did not show significant fluctuation (see Figure 4), the NRA thinks that the contribution of the outflow of the high radioactive concentration effluent to the radioactive material concentration in the port was small (it was reported that the radiation level of the radioactive materials having flowed out into the port this time was estimated at about 1.7×10^8 Bq for ^{90}Sr , while the radiation level of ^{90}Sr that has been daily flowing into the port from the bank protection of the unclosed section of the seaside impermeable wall, estimated by the 33th Committee on Supervision and Evaluation of the Specified Nuclear Facilities on March 25, 2015, is 2.7×10^9 Bq/day).

Figure 4. Results of analyzing radioactivity concentrations in the seawater in the port (excerpt from TEPCO's final report)
