Evaluation of the report of Tokyo Electric Power Company regarding the leakage from the 4000-t square steel tank cluster at the Fukushima Daiichi Nuclear Power Station

28 April 2015

Nuclear Regulation Authority, Japan

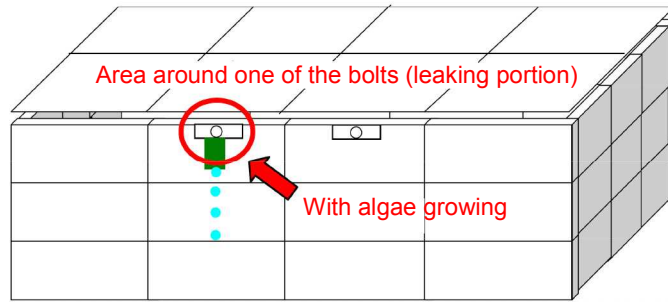
Leakage from tank No. 1-3

Around 14:00 on 2 June 2014, a nuclear safety inspector patrolling the site found water leaking from portions around bolts (refer to Figures 2 and 3) attached to the upper parts of the sides of two tanks (Nos. 1-3 and 1-5, 35 m³ tanks) of the 1000 t square steel tank (hereinafter, referred to as “notch tank”) cluster, which is part of the 4000 t notch tank cluster* (refer to Figure 1).

In the area concerned, water was observed to be dripping from portions around the bolts attached near the top panels of two tanks. The dripping rate was approximately one drop per second. We notified the electric utility of this event and ordered them to check the details.
