# Japan's Nuclear Regulation against Natural Hazards after the Fukushima Daiichi Accident

# NRA's New Regulation Standards against Natural Hazards after the Fukushima accident (Contents of this Presentation)

- ◆ More stringent standards on **tsunami**
- ◆ Clarification of requirements for **fault** displacement
- ◆ More precise methods to define design basis ground motion (DBGM) by **earthquake**
- ◆ Assessment & monitoring of **volcanic activity**
- ◆ An **example**: Sendai Nuclear Power Plants (NPPs), Kyushu Electric Power Co.

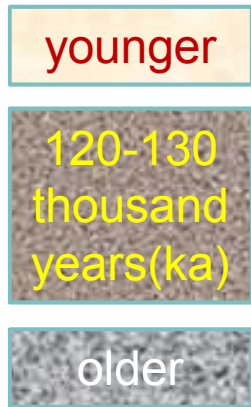
## 1. Covering Bed Method

Geological age of bed

Capable Fault

“Capable fault” is the official term for “active fault” that is defined in IAEA Safety Standards Series No. SSG-9 “Seismic hazards in site evaluation for nuclear installations”. The “120-130 ka” is the base age of Upper Pleistocene.

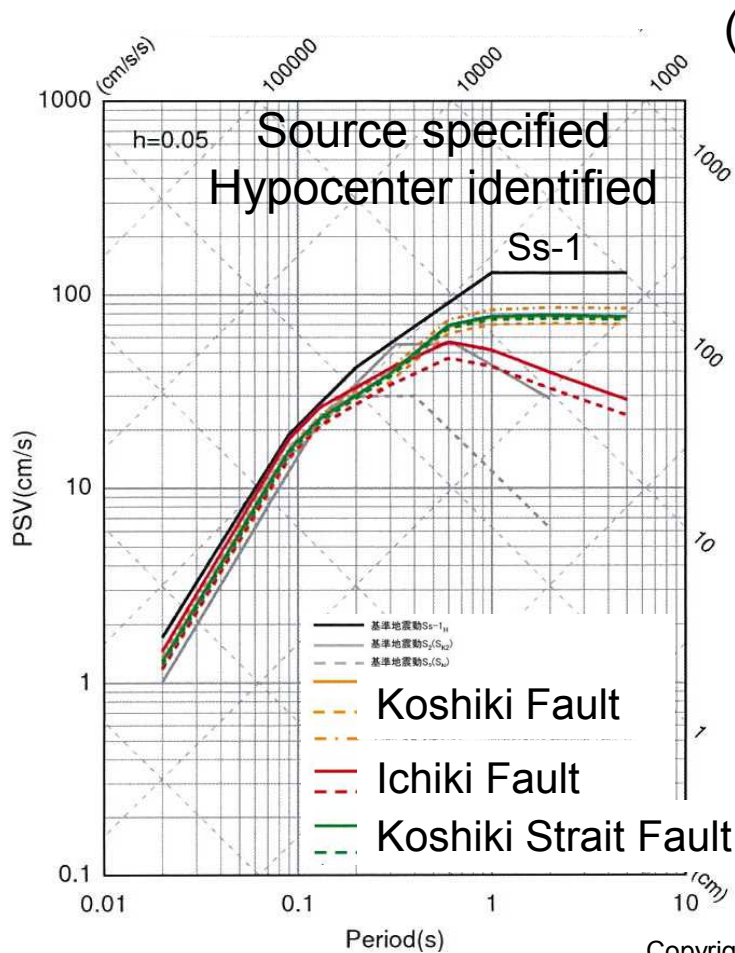
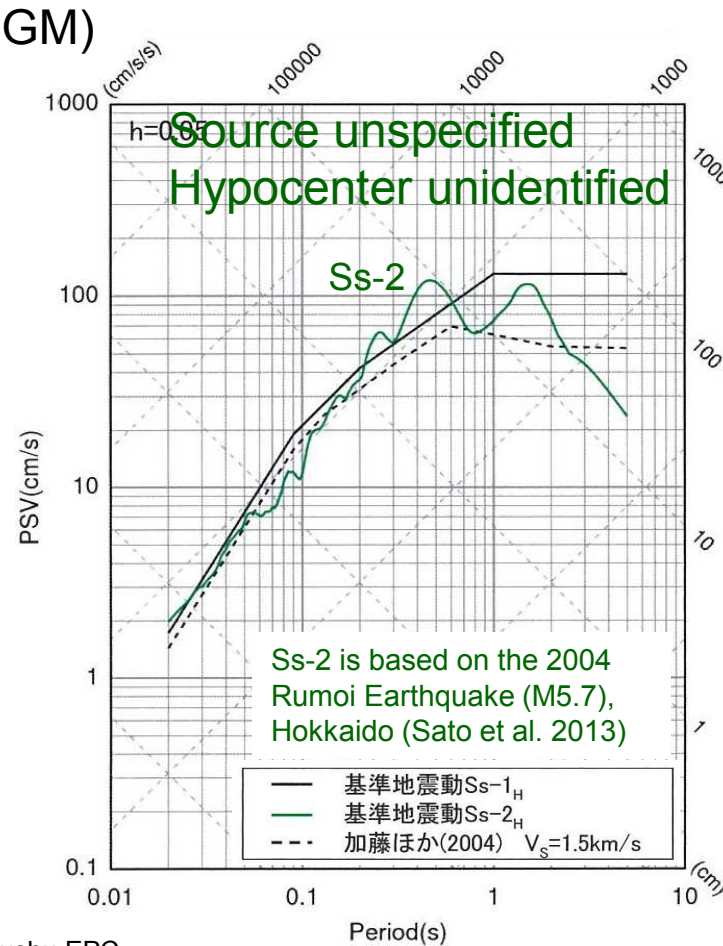
# Design Basis Ground Motion of Sendai NPPs

Horizontal movement

Ss-1 and Ss-2 are DBGMs for Sendai NPPs.

The Ss-2 “hypocenters-unidentified” earthquake is assumed to occur in the earth’s crust just beneath the NPPs.

The Ss-2 is larger than the Ss-1 in some periods.
