原子力施設等におけるトピックス
(令和2年9月21日～9月27日)

令和2年9月30日
原子力規制庁

玄海原子力発電所3号機における火災の発生について

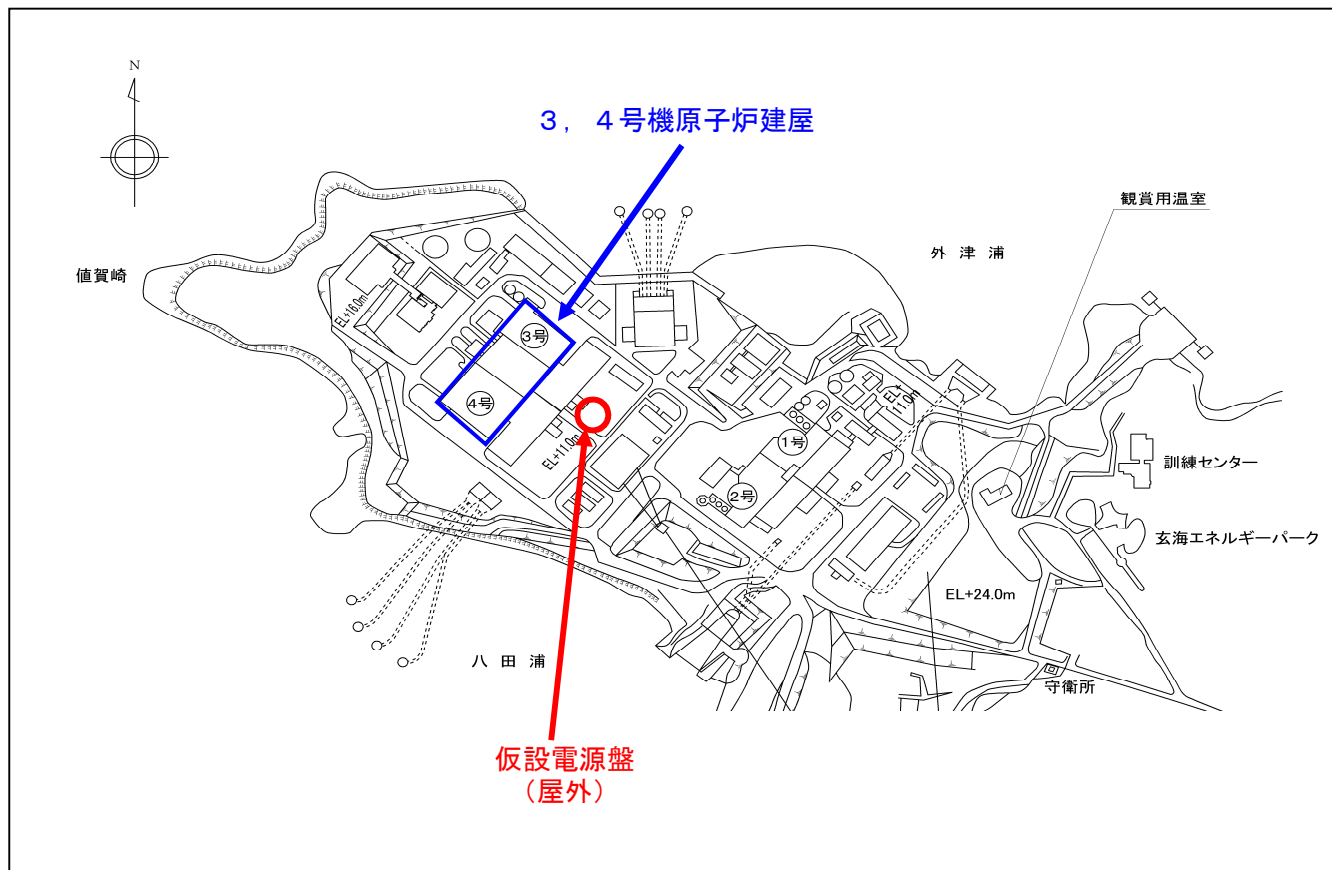
玄海原子力発電所概要図

定期検査を実施中の玄海原子力発電所3号機（加圧水型軽水炉、定格電気出力118万キロワット）において、本日13時40分頃、屋外に設置した仮設電源盤に接続している仮設ケーブルから、発火及び発煙を確認したため、消火活動を行うとともに公設消防へ通報を行いました。
